2007 Mercedes-Benz S600 Front-Passenger Seat Occupancy Recognition Troubleshooting

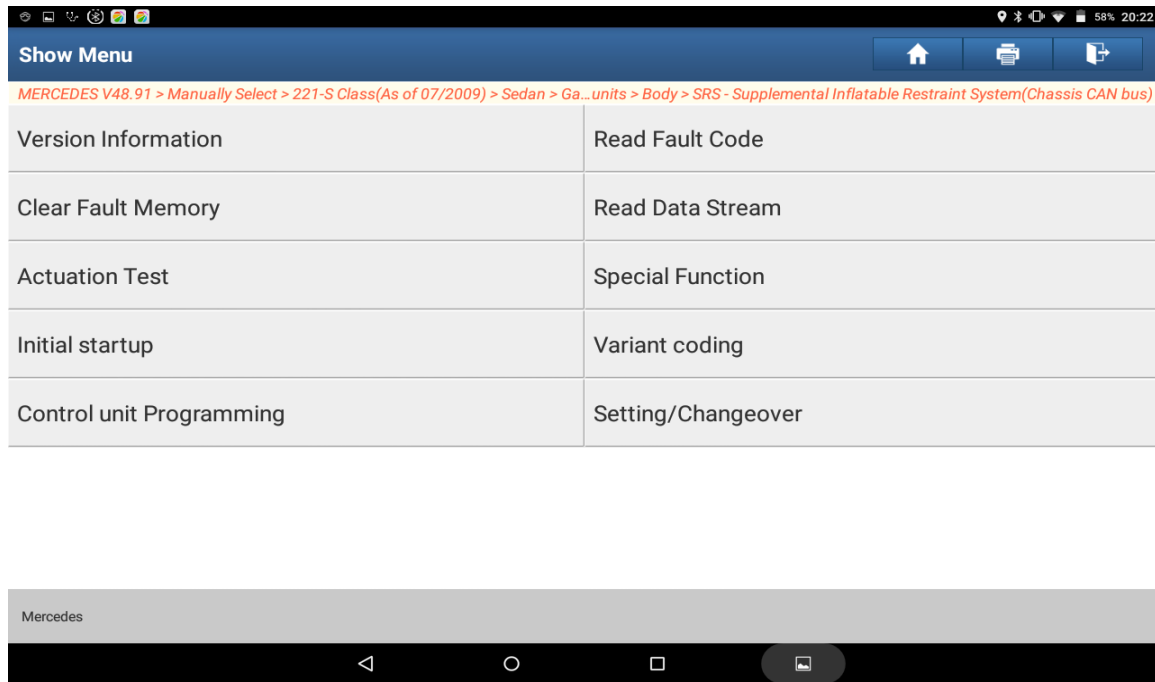
Picture 3

3) Check the airbag related circuit and sensor, no error. Return to select "Hide and Refit", see Picture 3.

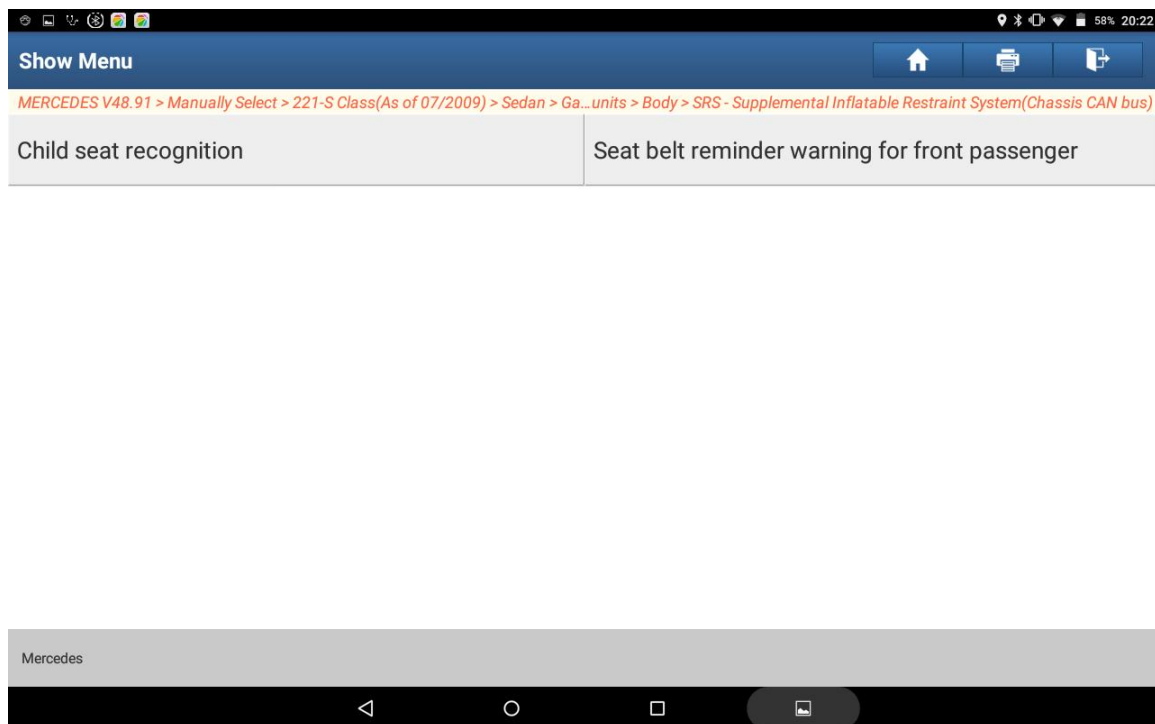
Picture 4

4) Select "Child seat recognition", see Picture 4.

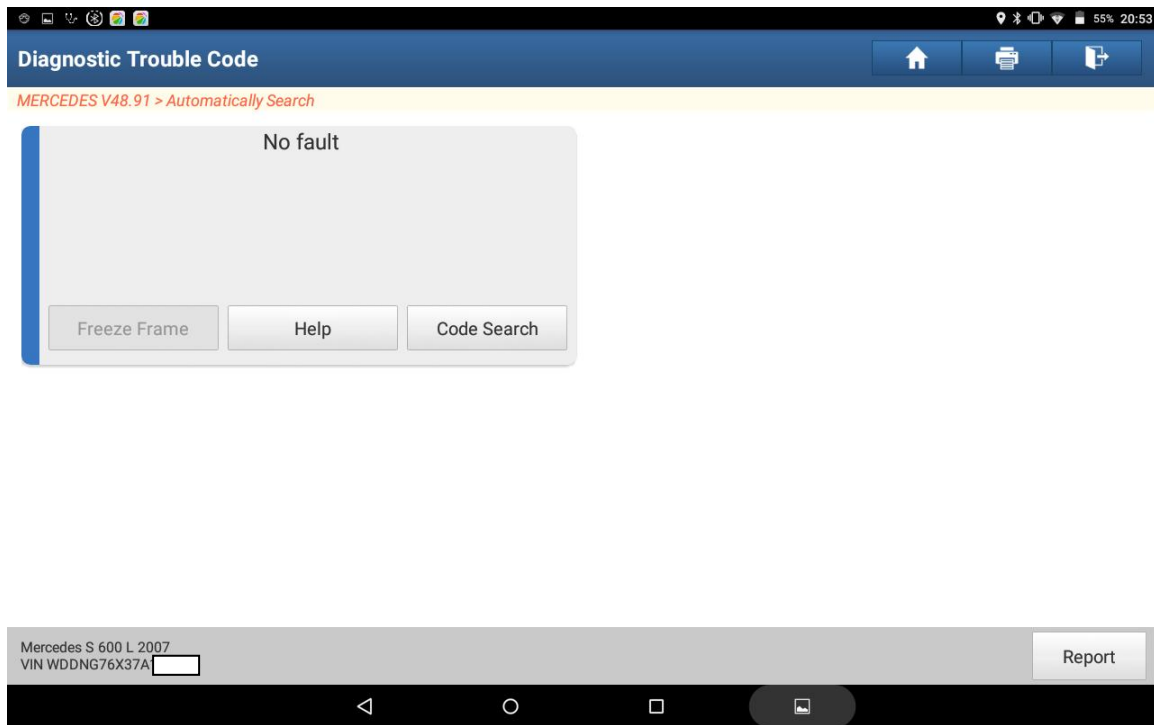
Picture 15

15) Return, the fault code can now be removed, see Picture 15.
