Benz E300L Service Reset

Function description: service lamp reset

Supported products: Launch PRO or PAD series comprehensive diagnostic equipment

Tested model: Benz E300L VIN: LE4ZG8DB5ML70**** (see the following figure)

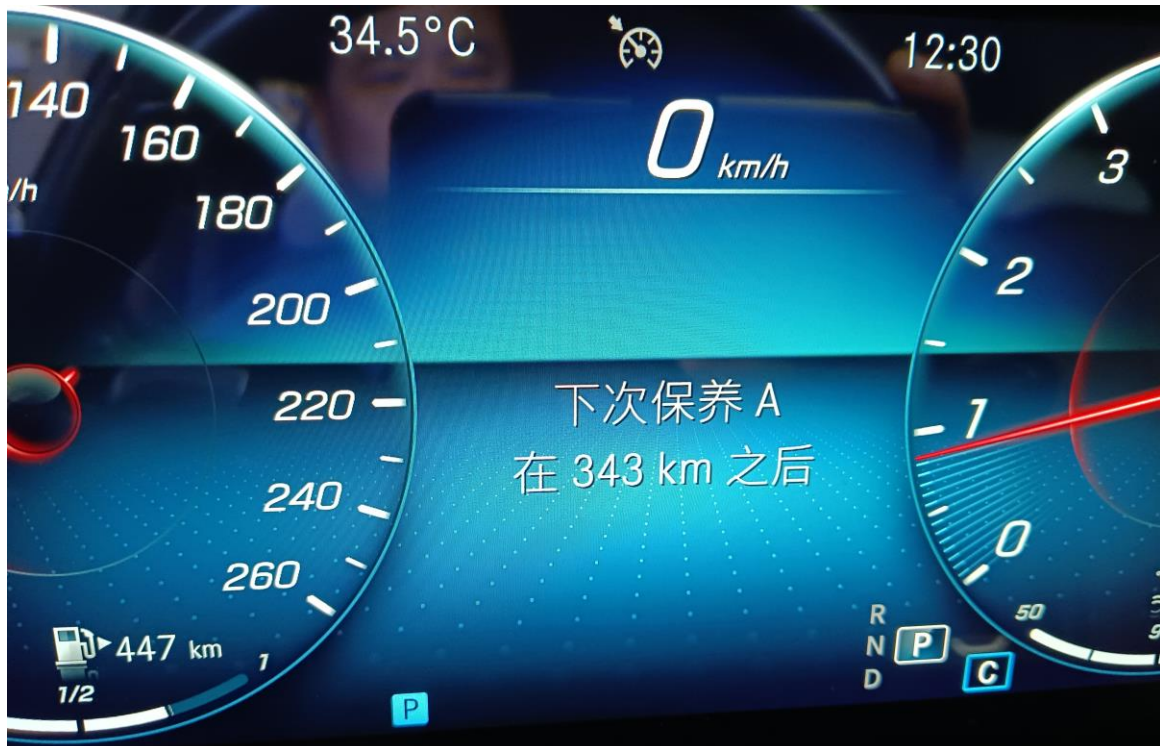
The instrument cluster prompts that the next service A will be after 343 kilometers.
(See the following figure.)

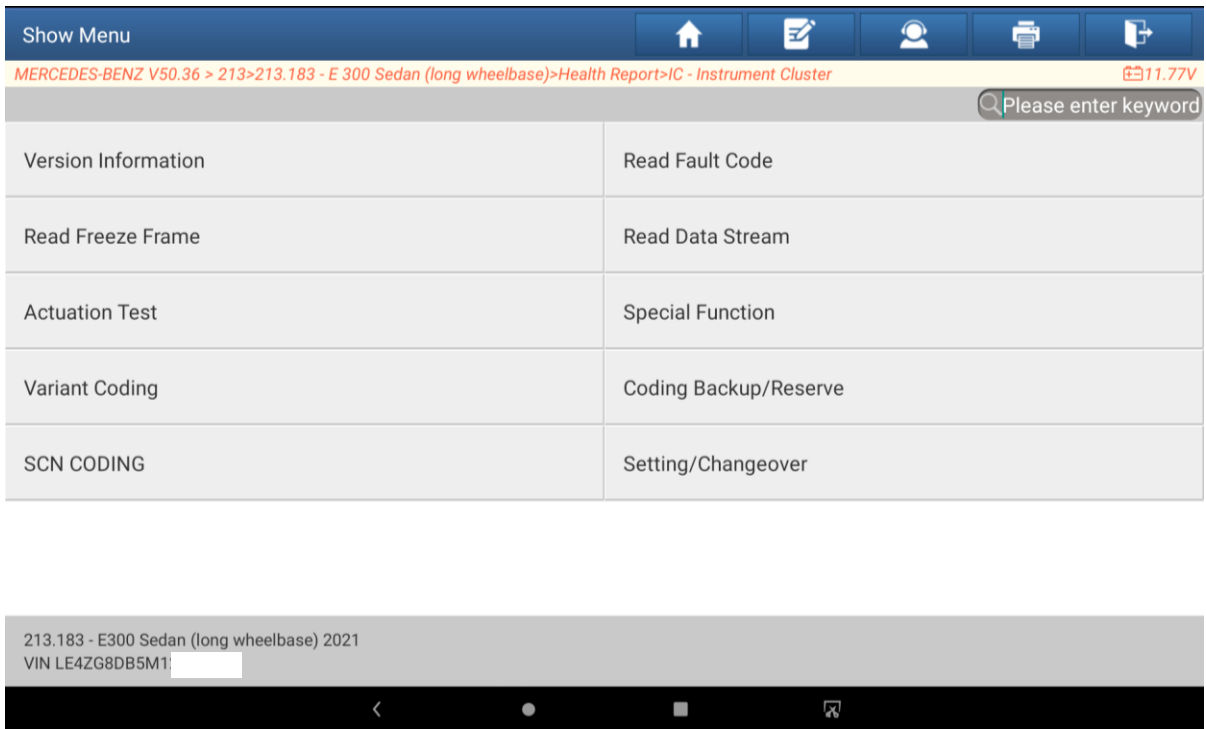
2. Choose [Actuation Test]. (See the following figure.)

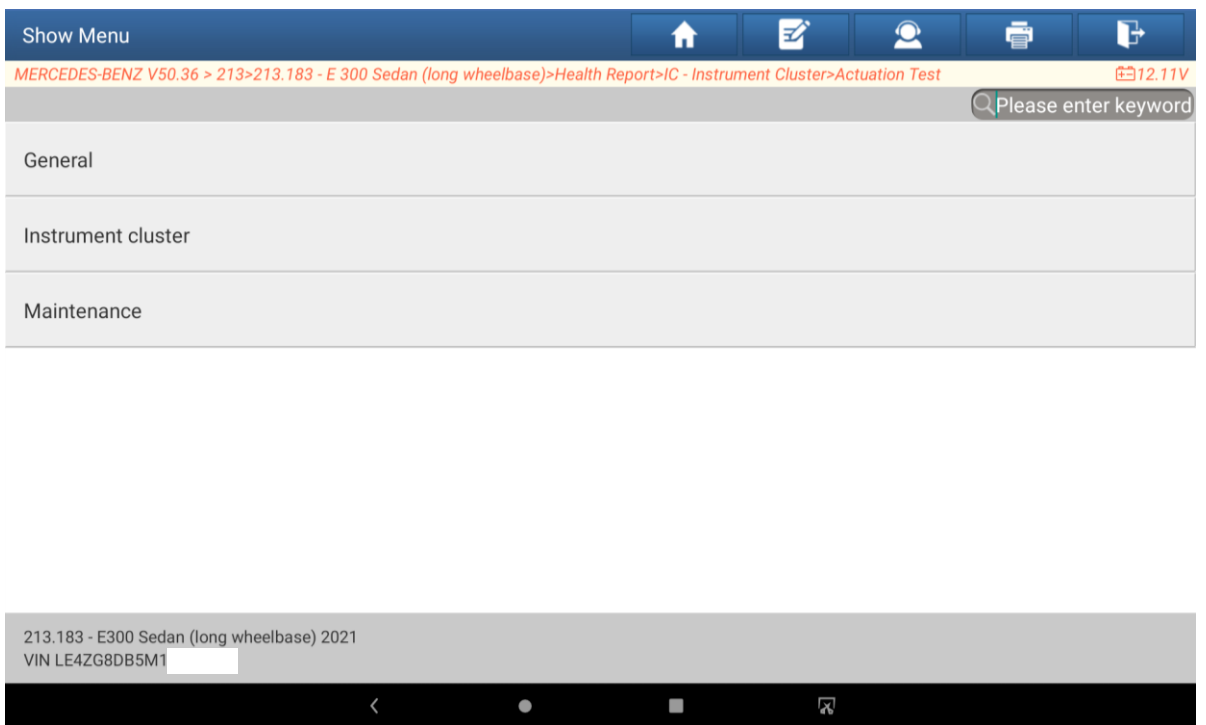
3. Choose [Maintenance]. (See the following figure.)

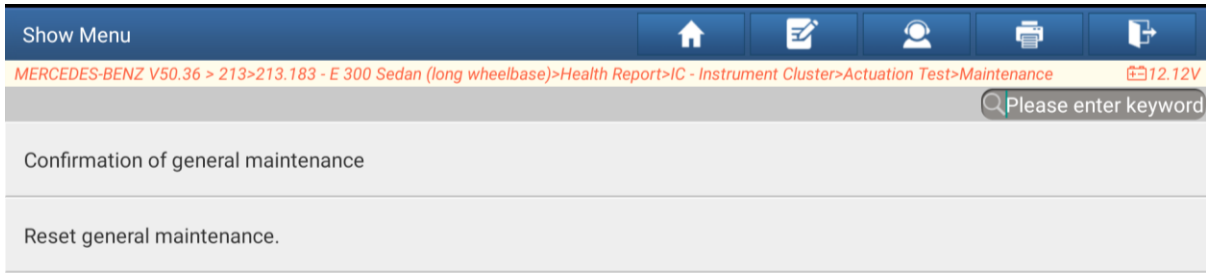
4. Choose [Confirmation of general maintenance]. (See the following figure.)

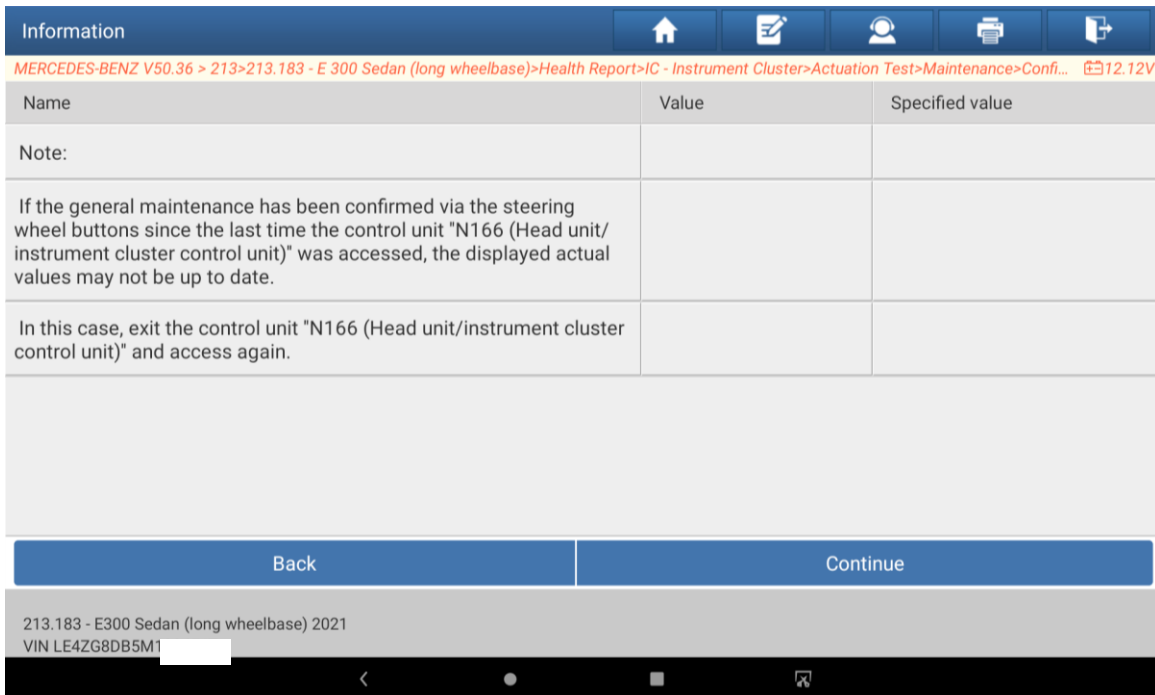
5. Click [Continue]. (See the following figure.)

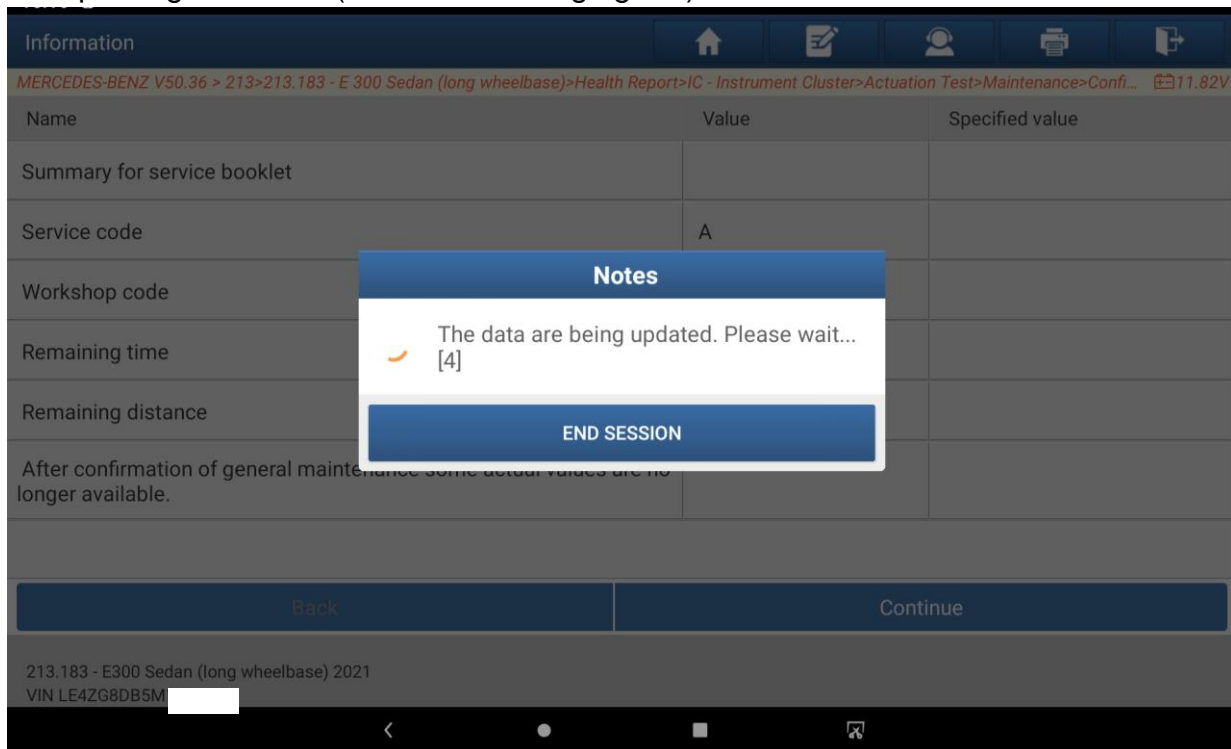
7. Updating the data...(See the following figure.)

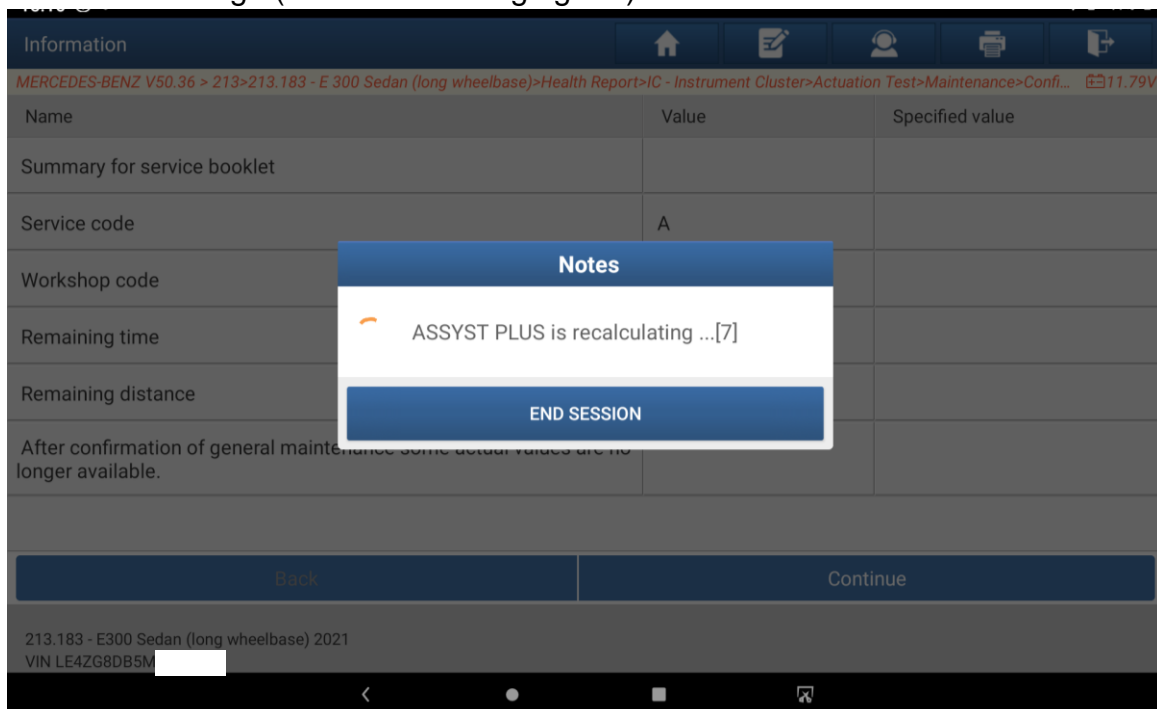
8. Recalculating...(See the following figure.)

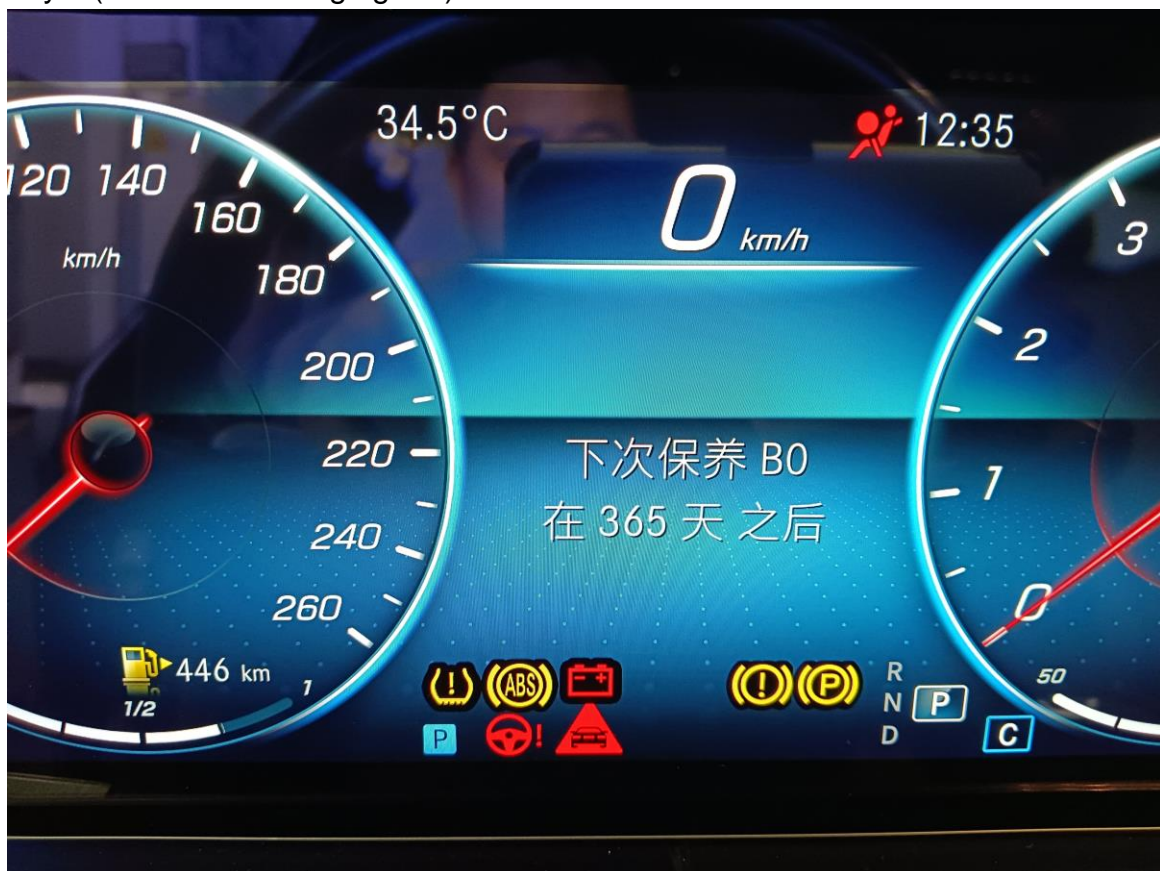
9. Service reset is completed. The instrument cluster prompts that the next service B0 is after 365 days. (See the following figure.)
