B1216 LEFT HEATED SEAT LO INDICATOR CONTROL CIRCUIT HIGH

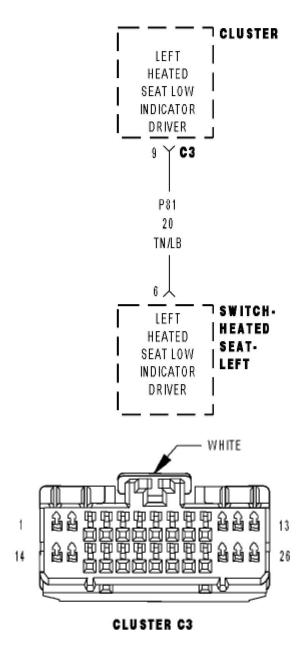
- When Monitored: Continuously with the ignition on.
- 2). Set Condition:

This code is set immediately when the Cluster detects excessive voltage on the heated seat indicator control circuit.

- 1. (P81) LEFT HEATED SEAT LO INDICATOR DRIVER CIRCUIT SHORTED TO BATTERY
- 2. LEFT HEATED SEAT SWITCH
- 3. CLUSTER

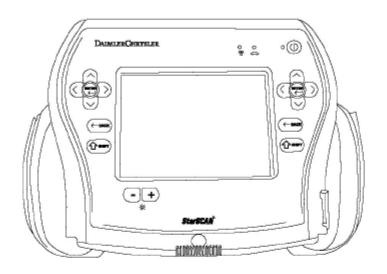
2). DISCONNECT THE DRIVER HEATED SEAT SWITCH AND RE-READ DTC

Disconnect the Left Heated Seat Switch connector.

With the scan tool erase DTC's

Cycle the ignition switch off then back on.

With the scan tool, read DTC's.

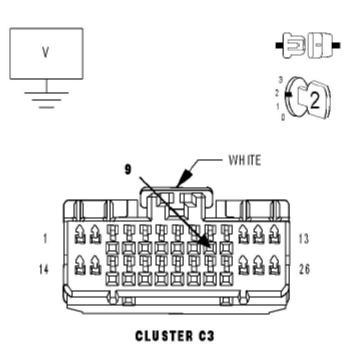
3). DISCONNECT THE CLUSTER C3 CONNECTOR AND CHECK FOR VOLTAGE

Disconnect the Cluster C3 connector.

Measure the voltage at the (P81) Left Heated Seat High Indicator Driver circuit at the Cluster C3 connector.
