B1607 HEADLAMP SWITCH INPUT CIRCUIT LOW

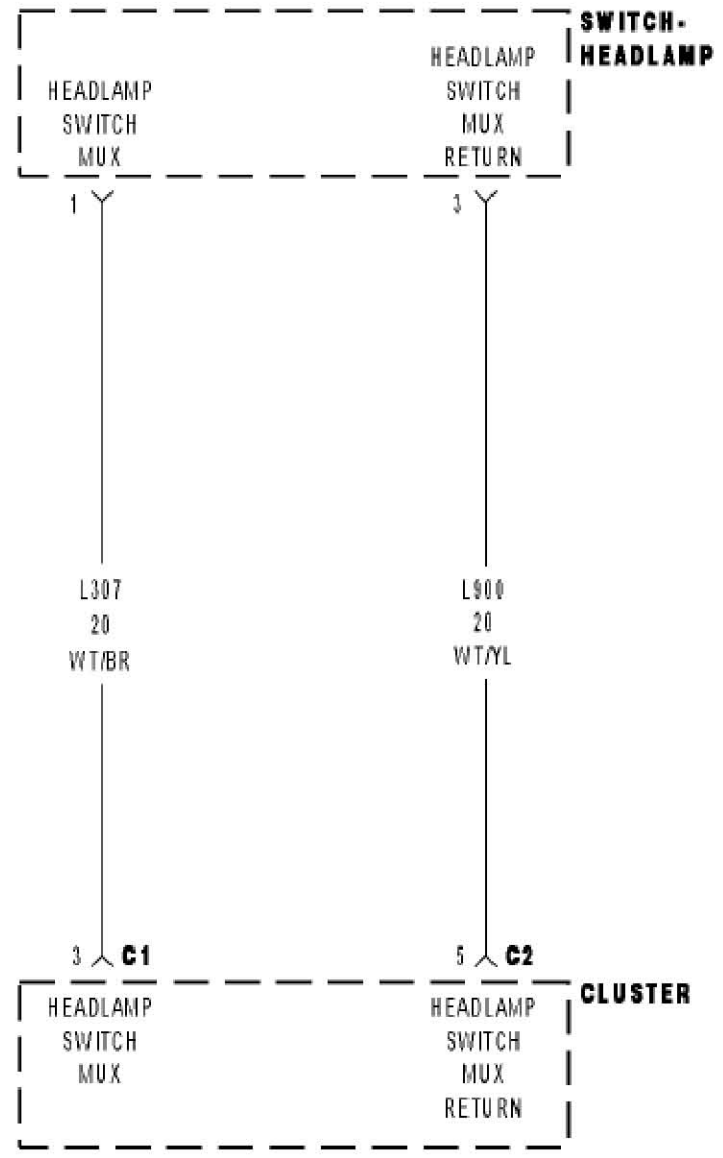
Possible Causes

1. HEADLAMP SWITCH
2. (L900) MUX RETURN CIRCUIT
3. INSTRUMENT CLUSTER
