Seat Motor Calibration for 2013 Porsche Cayenne

Product Model	Date	Number
X-431 Pro series	20160310

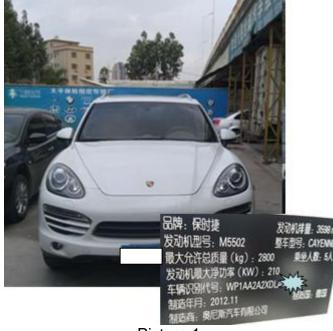
Picture 1

• Porsche Cayenne (2011-), 2013MY, VIN=WP1AA2A2XDLA*****, see Picture 1.
