P2122: Pedal Position Sensor (Main) Circuit Low Input

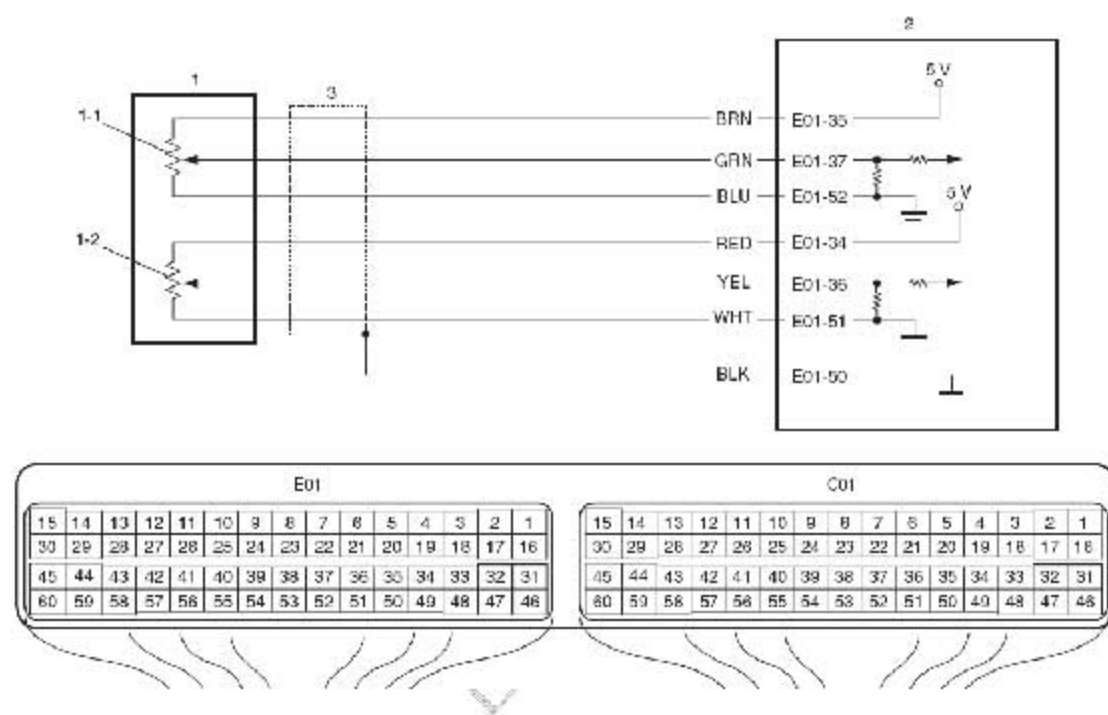
Wiring Diagram

1. APP sensor assembly	1-2. APP sensor (sub)	3. Ground of APP sensor for shield wire
1-1. APP sensor (main)	2. ECM

Step	Action	Yes	No
4	<p>ECM voltage check</p> <p>1) Disconnect connector from APP sensor assembly with ignition switch turned OFF.</p> <p>2) Check for proper connection to APP sensor assembly at "BRN", "GRN" and "BLU" wire terminals.</p> <p>3) If OK, measure voltage between "BRN" wire terminal of APP sensor assembly connector and vehicle body ground with ignition switch turned ON.</p> <p>Is voltage 4 – 6 V?</p>	Go to Step 7.	Go to Step 5.
5	<p>ECM voltage check</p> <p>1) Turn OFF ignition switch.</p> <p>2) Remove ECM from its bracket with ECM connectors connected.</p> <p>3) Check for proper connection of ECM connector at "E01-35" terminal.</p> <p>4) If OK, measure voltage between "E01-35" terminal of ECM connector and engine ground with ignition switch turned ON.</p> <p>Is voltage 4 – 6 V?</p>	"BRN" wire is open or high resistance circuit.	Go to Step 6.
6	<p>Wire harness check</p> <p>1) Disconnect connectors from ECM with ignition switch turned OFF.</p> <p>2) Measure resistance between "E01-35" terminal of ECM connector and engine ground.</p> <p>Is resistance infinity?</p>	Substitute a known-good ECM and recheck.	"BRN" wire is shorted to ground circuit.
