Instructions for Replacement of Steering Column

Basic Setting and Software Refreshing of VW NSK Second-Generation Steering Wheel System

Tested Model:

VW, New Lavida 184*/New Gran Lavida/New Cross Lavida 185*, VIN code: LSVNV4188FN0 8****

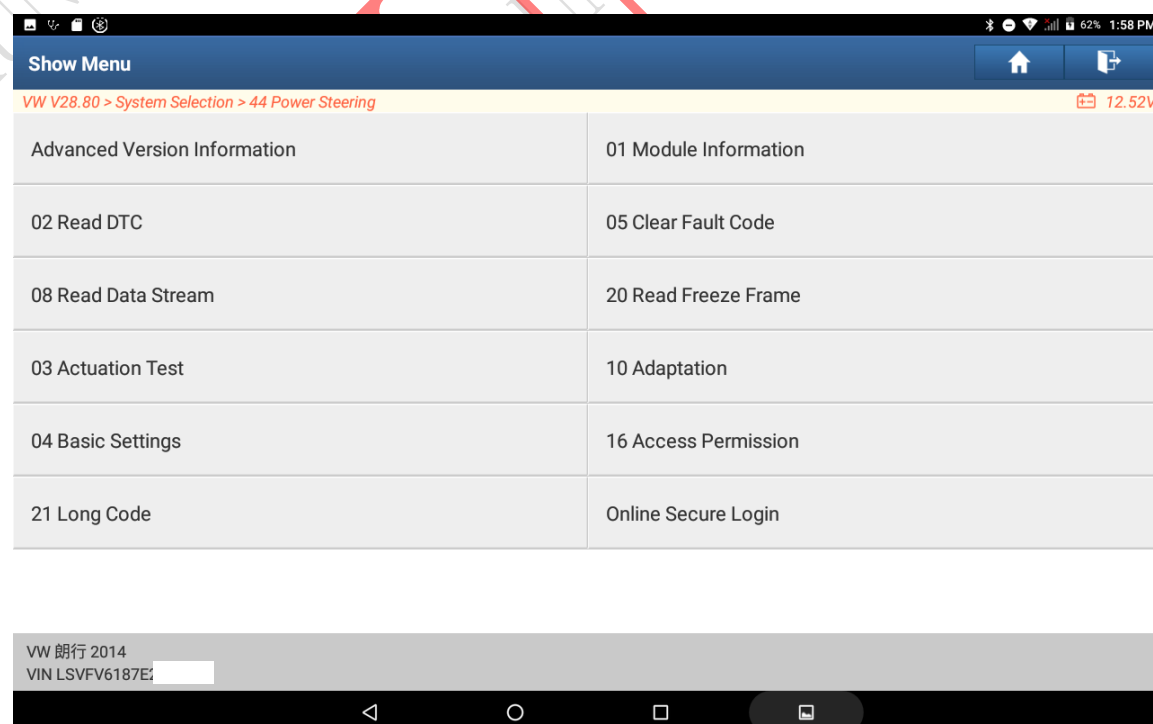
Figure 1

1. Only for New Lavida, Gran Lavida, New Santana and New POLO produced by Shanghai VW. Choose VW V28.80 > System Selection > 44 Power Steering. See Figure 1.

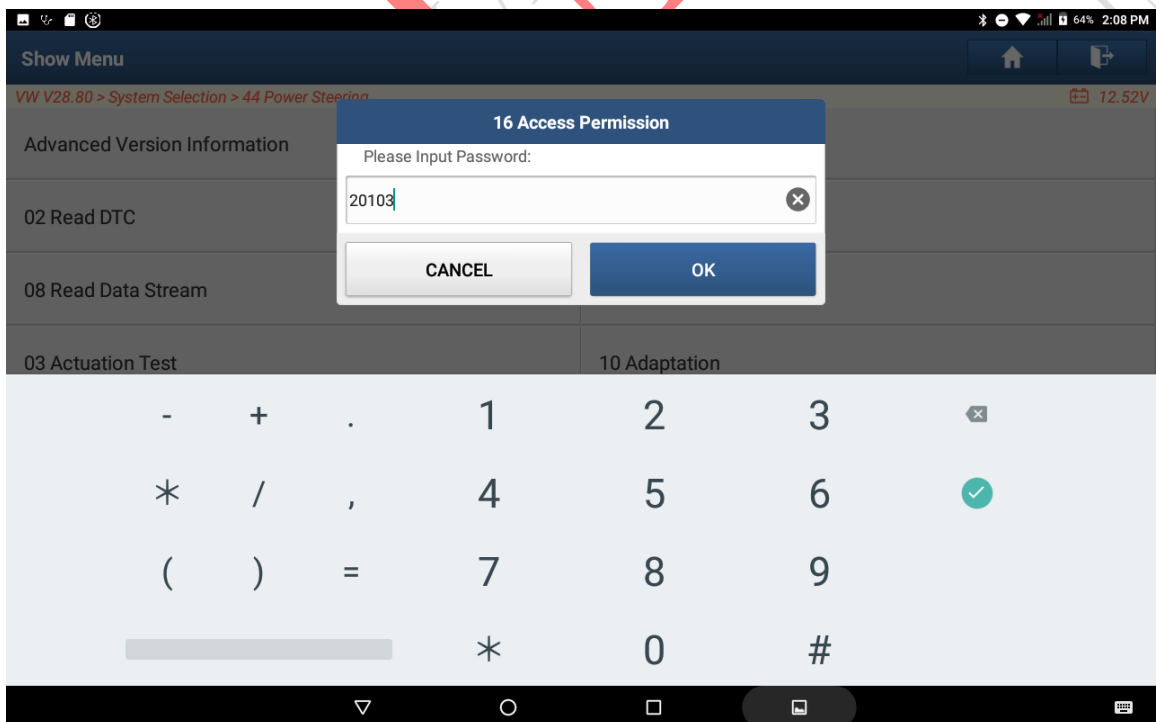
Figure 3

- First perform [16 Access Permission], and input “20103”. See Figure 3. Perform the next step after successful login.

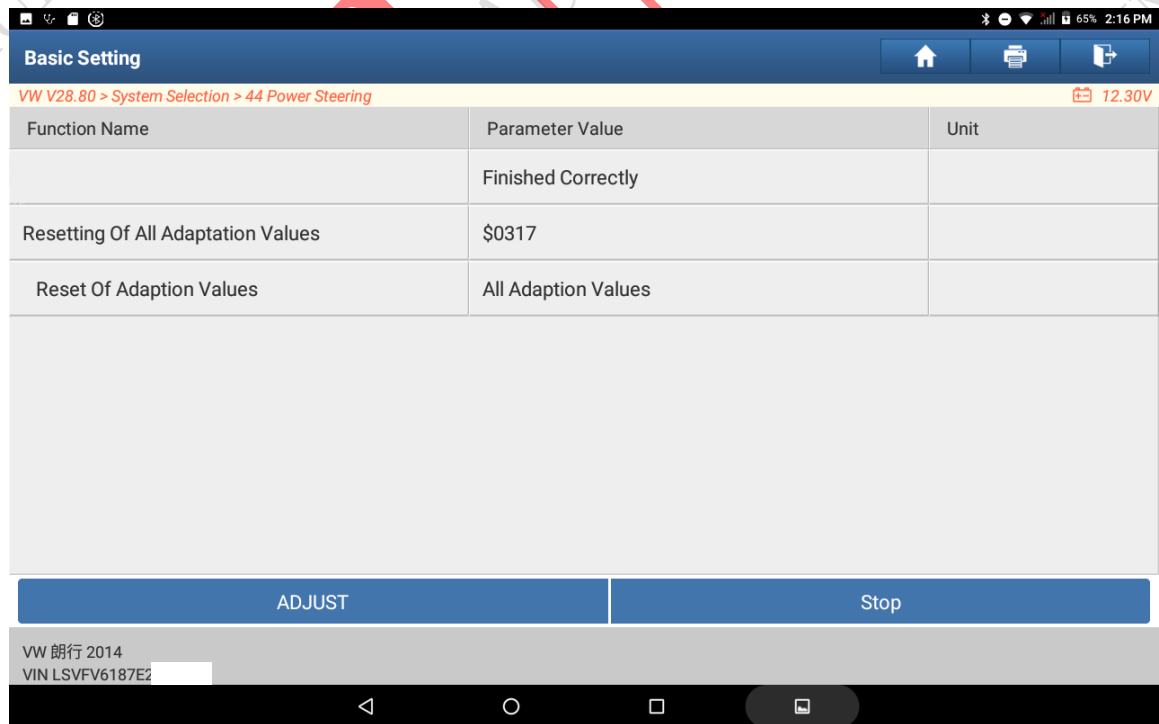
Figure 5

5. Perform [Resetting of All Adaptation Values]. See Figure 5. After it is successfully performed, take the next step.

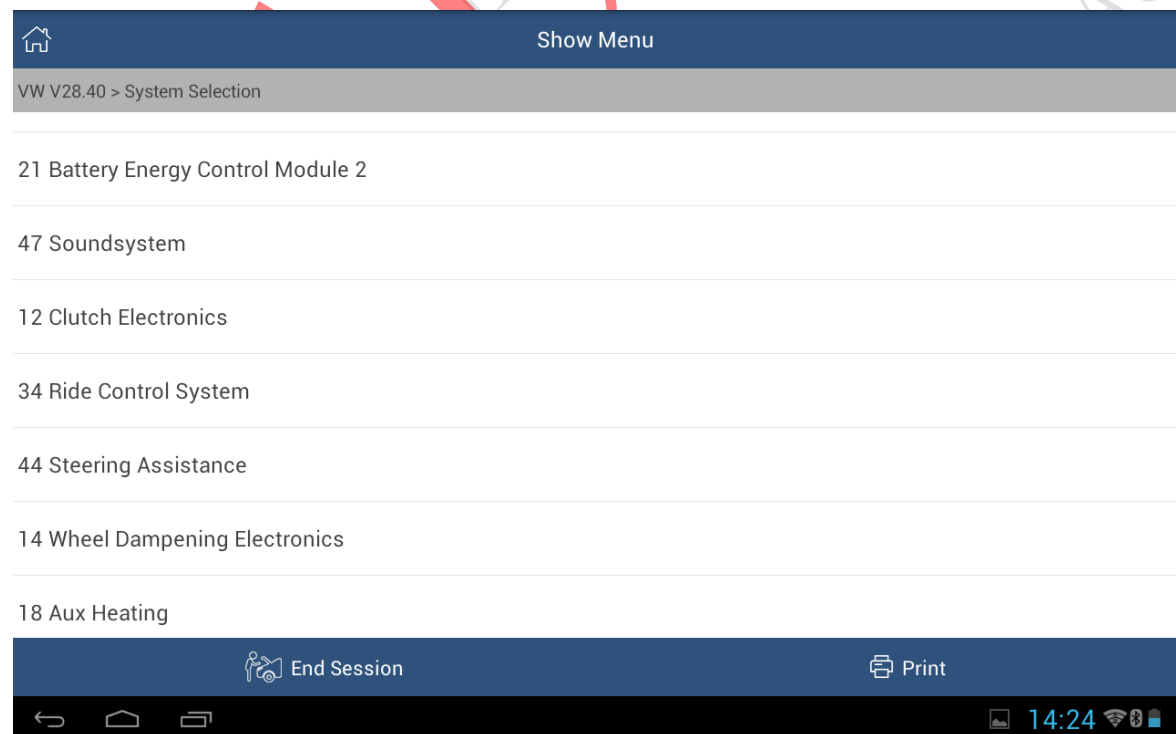
2. Click to enter [System Selection], and then choose [44 Power steering system].

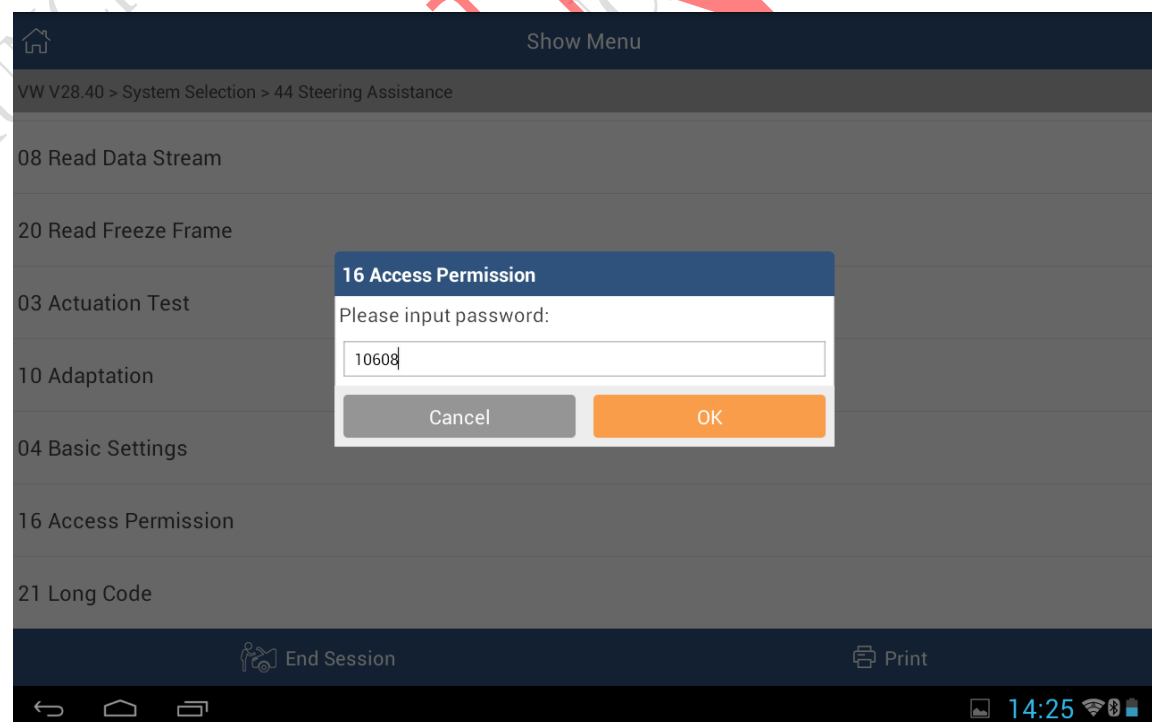
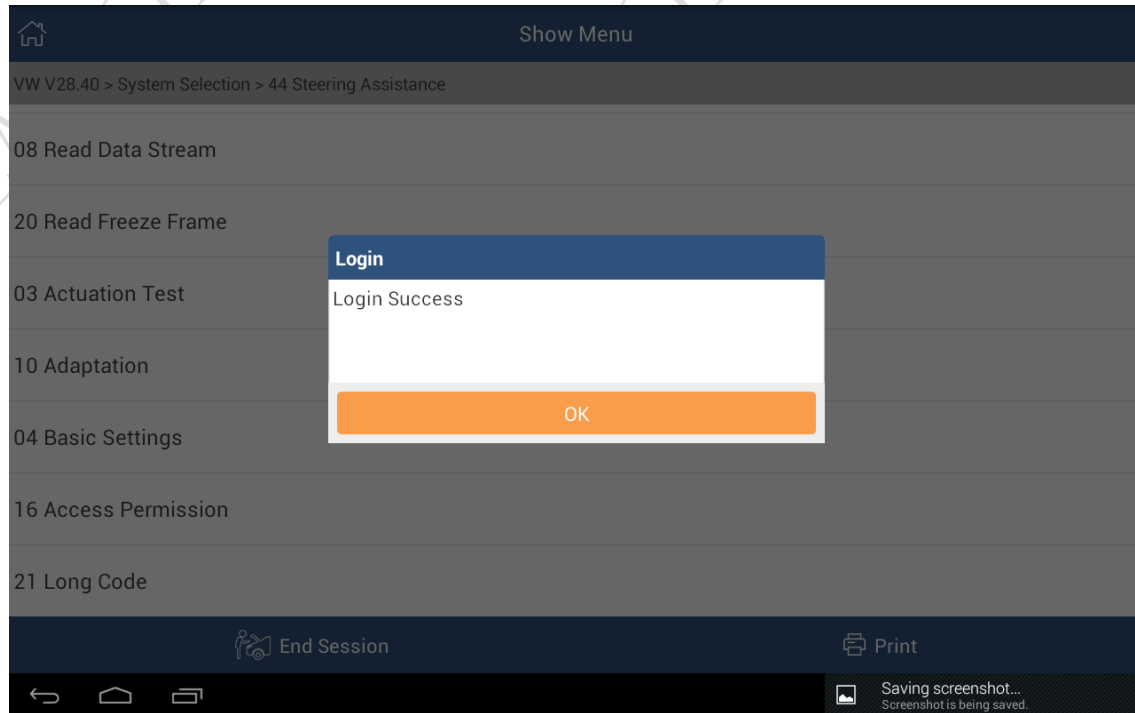
3. The following functions are displayed after entering the 44 Power steering system. Choose [16 Access Permission], the password is 10608. Click OK after successful login.

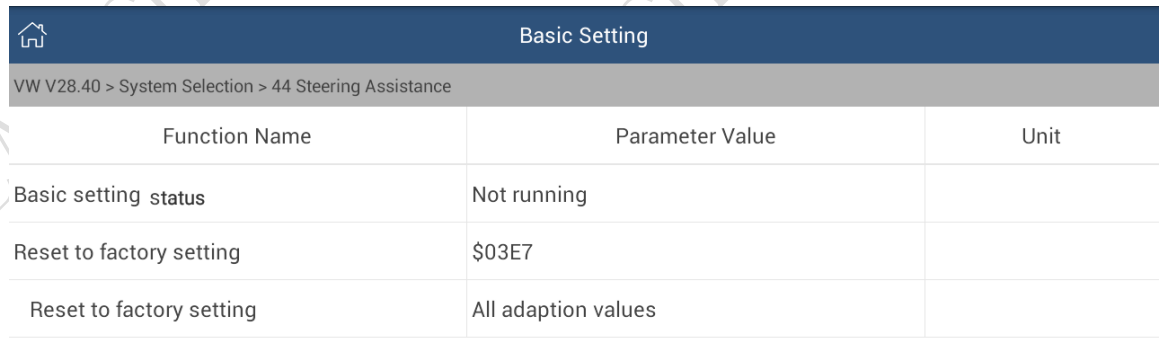
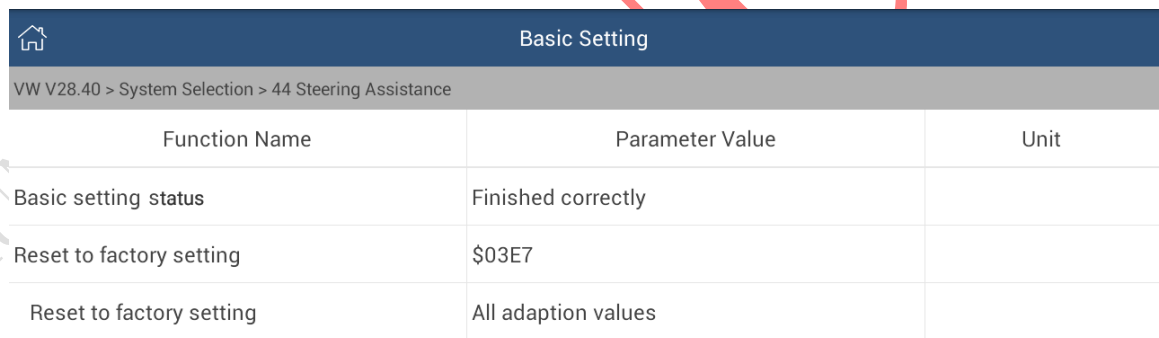
- After successful login, perform [04 Basic System Adjustment]. Select “Reset to factory setting”, and then click Confirm to start the Basic Setting. Click ADJUST and wait until the basic setting status changes to “Finished correctly”.

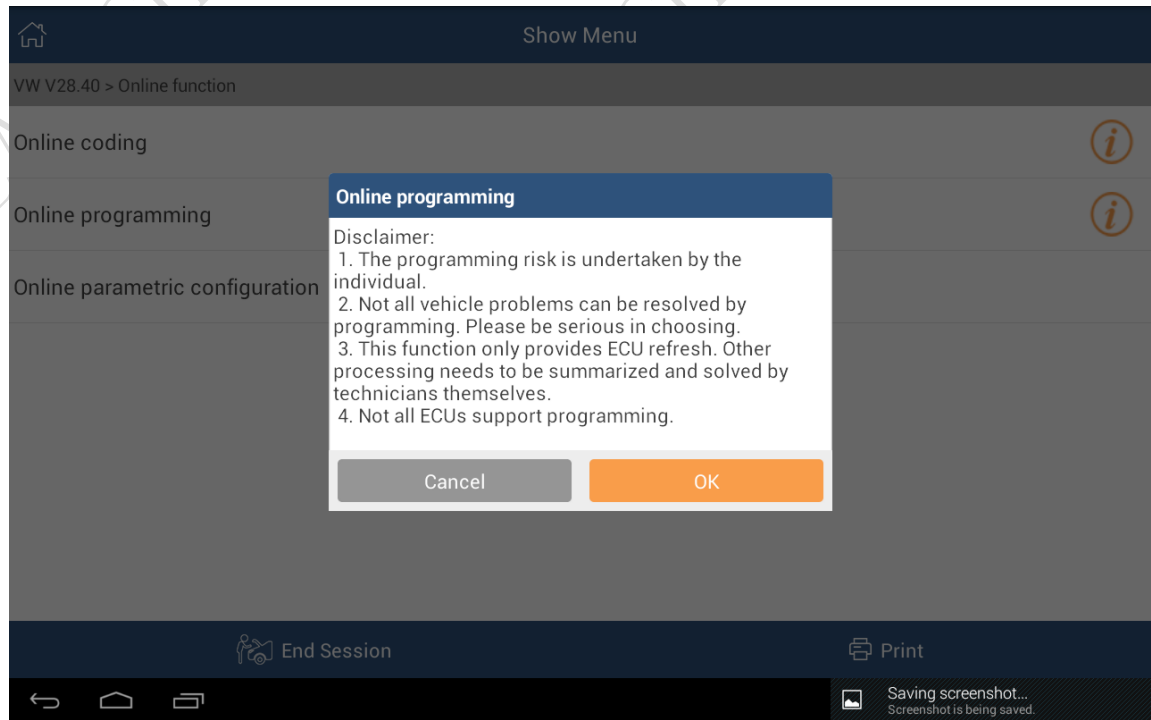
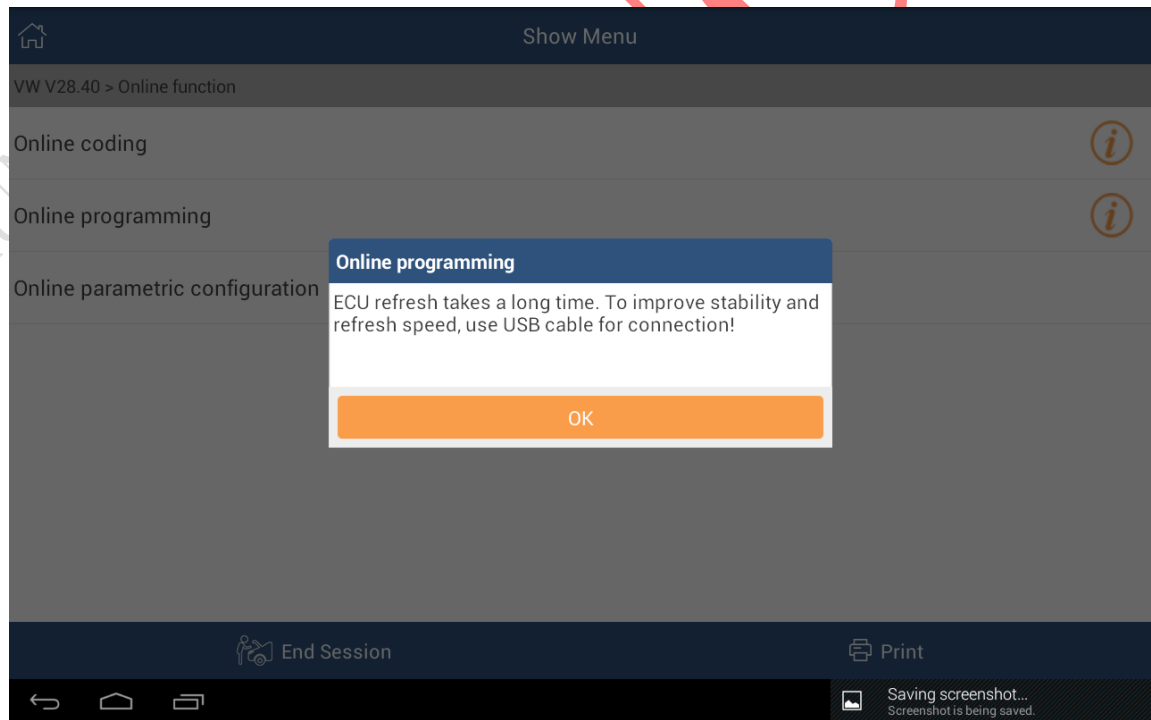
6. As for the DTC “B201300 No Band End Programming Occurs”, online programming would be performed to clear it. Select [Online function] in the main menu, and the following menu will show up. Select [Online programming]. The procedure and notes are shown as follows.

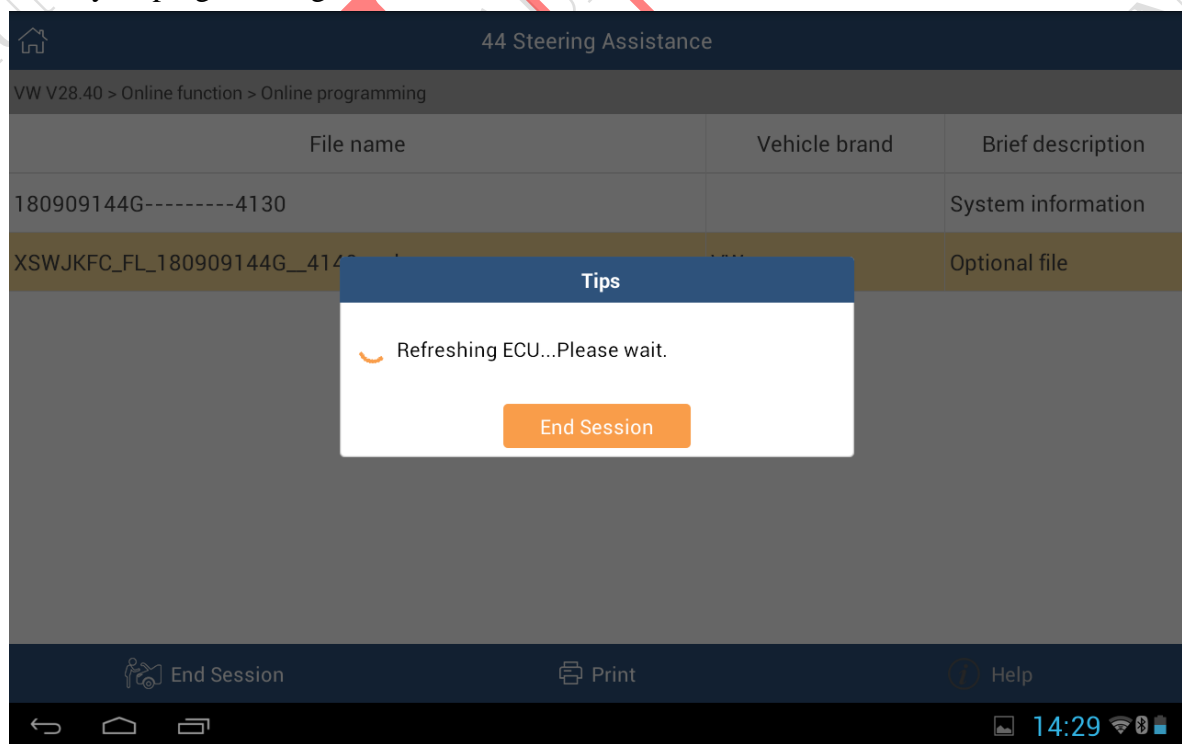
11. After downloading the files, click Continue to start ECU reprogramming until it says reprogramming is successful.

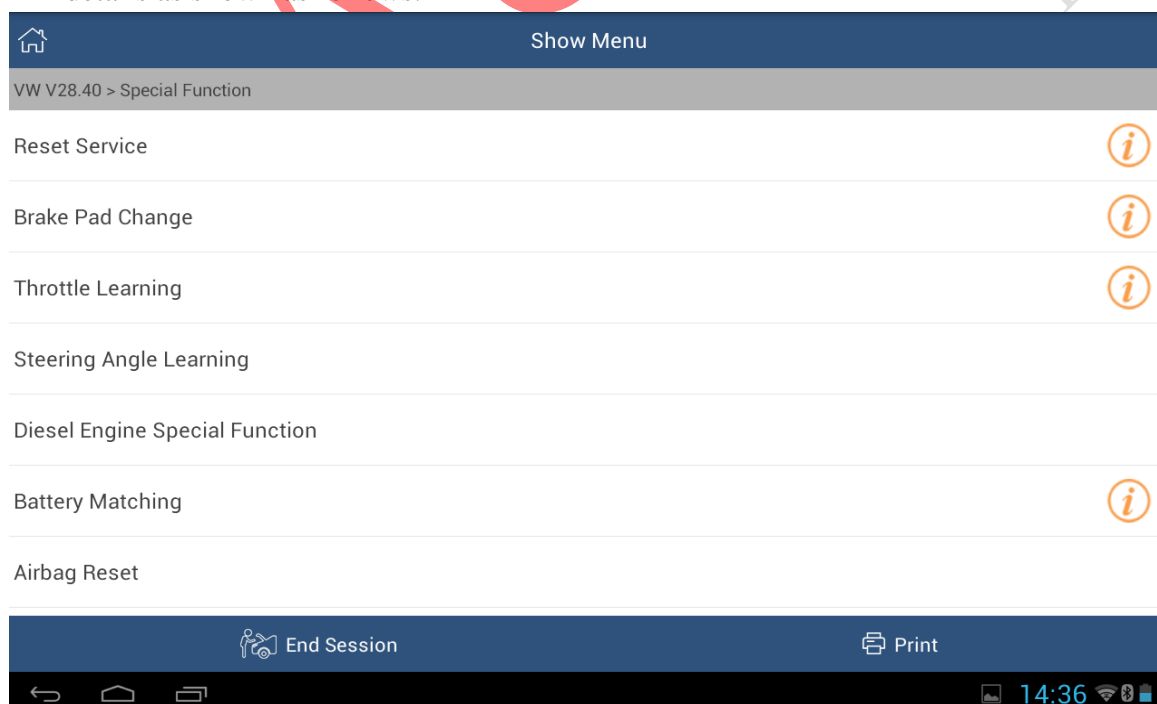
- For the DTC “C10ACF0 Steering System- unlearned end position Active/Static”, full lock position setting of the steering wheel would be needed. Turn the steering wheel to the left and right full lock position respectively and stop for a few seconds until you can hear “Ding Ding Ding” from the instrument, which means the setting is successful and the DTC could be deleted.
- For the DTC “B116854 Steering Angle Sensor, No Basic Setting Active/Static”, the special function of [Steering Angle Learning] needs to be performed. The details as shown as follows.

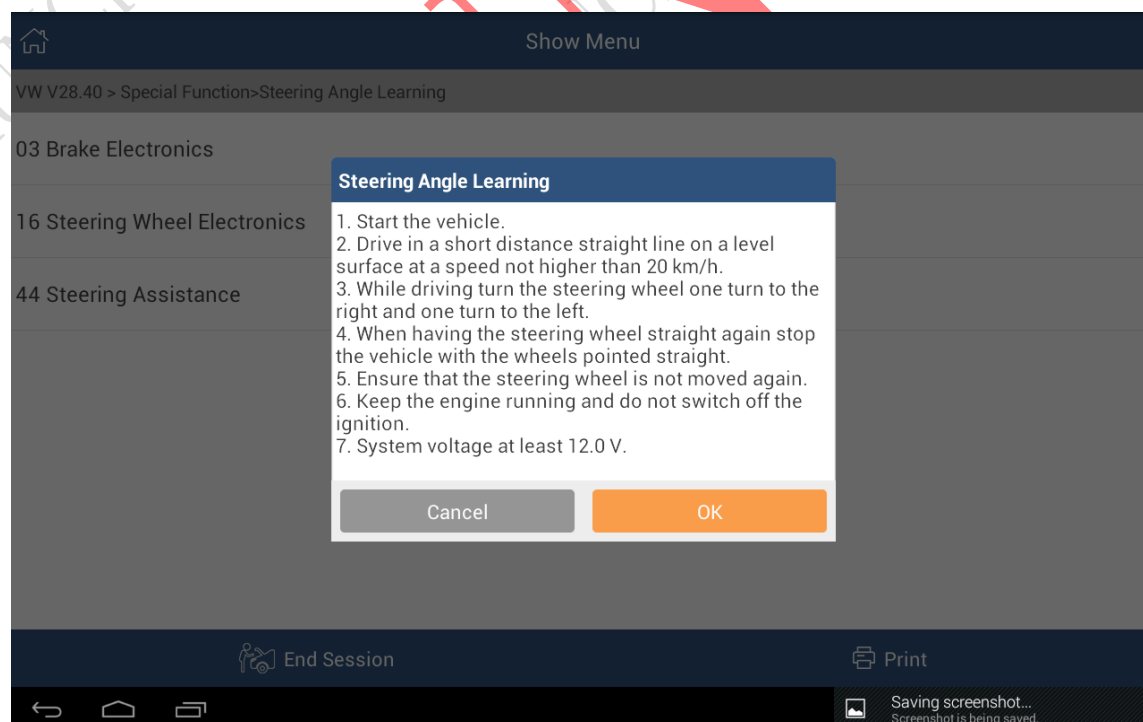
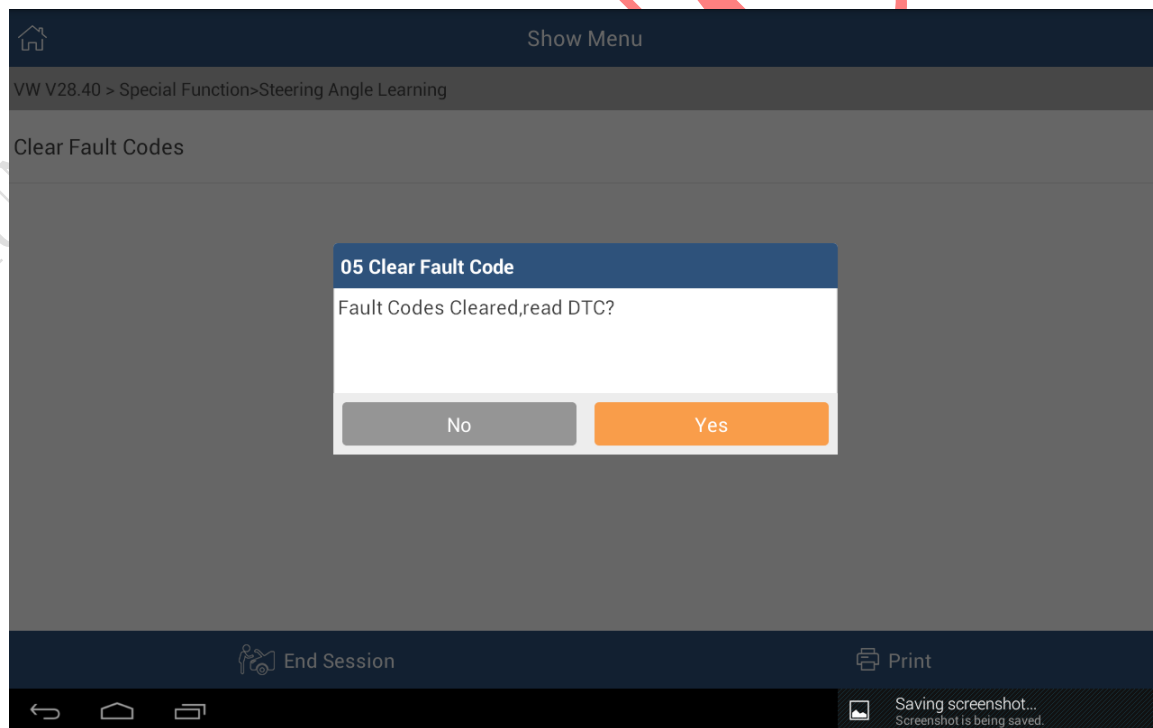
15. Here we select [03 Brake System]. After we select it, the notes are shown as follows. Click OK to start the reading and clearing of fault codes.

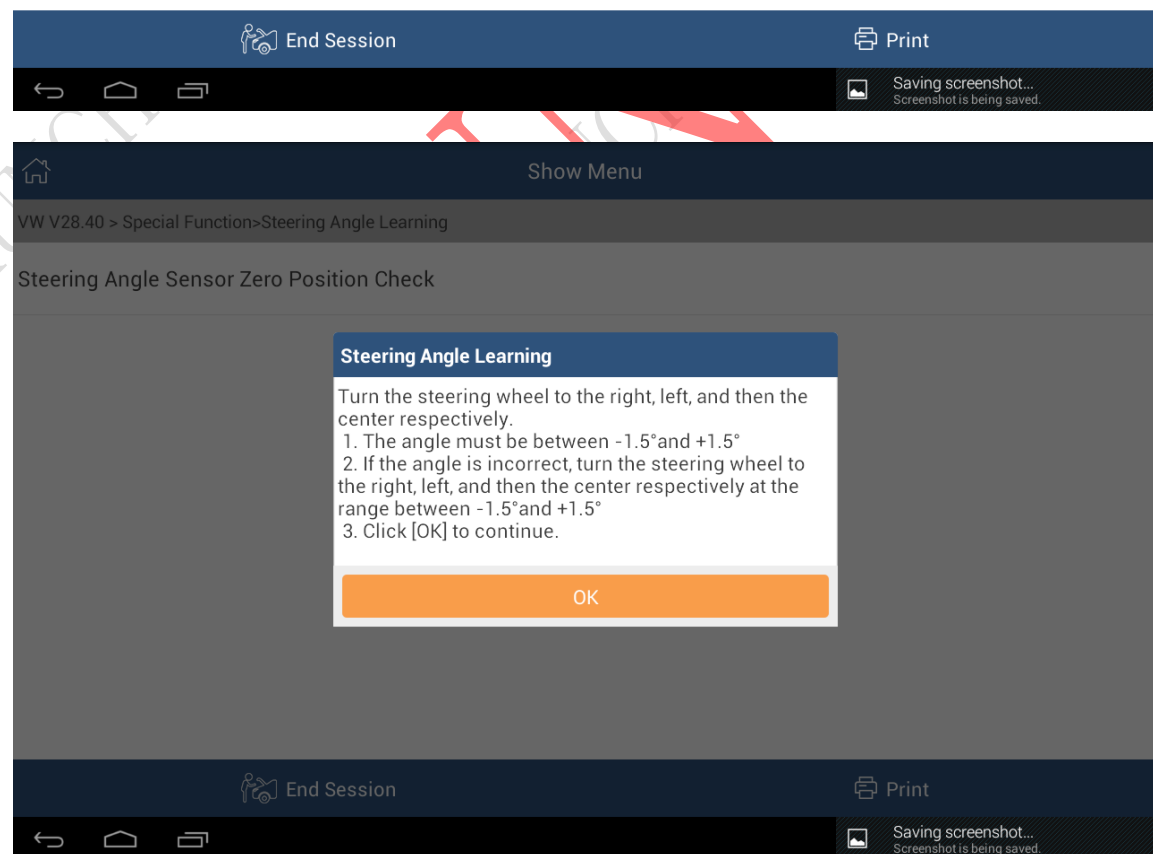
16. Then perform [Steering Angle Learning] > [Steering Angle Sensor Zero Position Check]. Please follow the prompts and make sure all the conditions within the prompts are met.

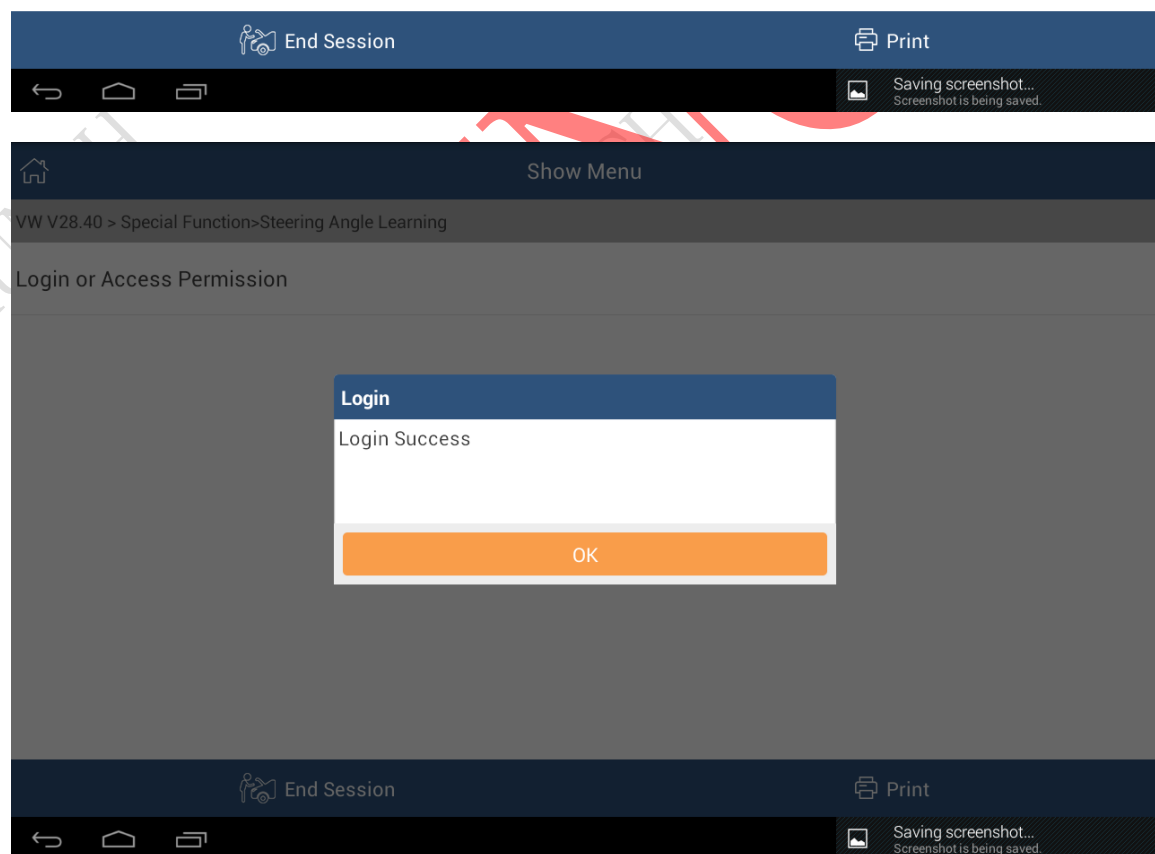
18. Next perform [Access Permission]. The message Login Success will be displayed.

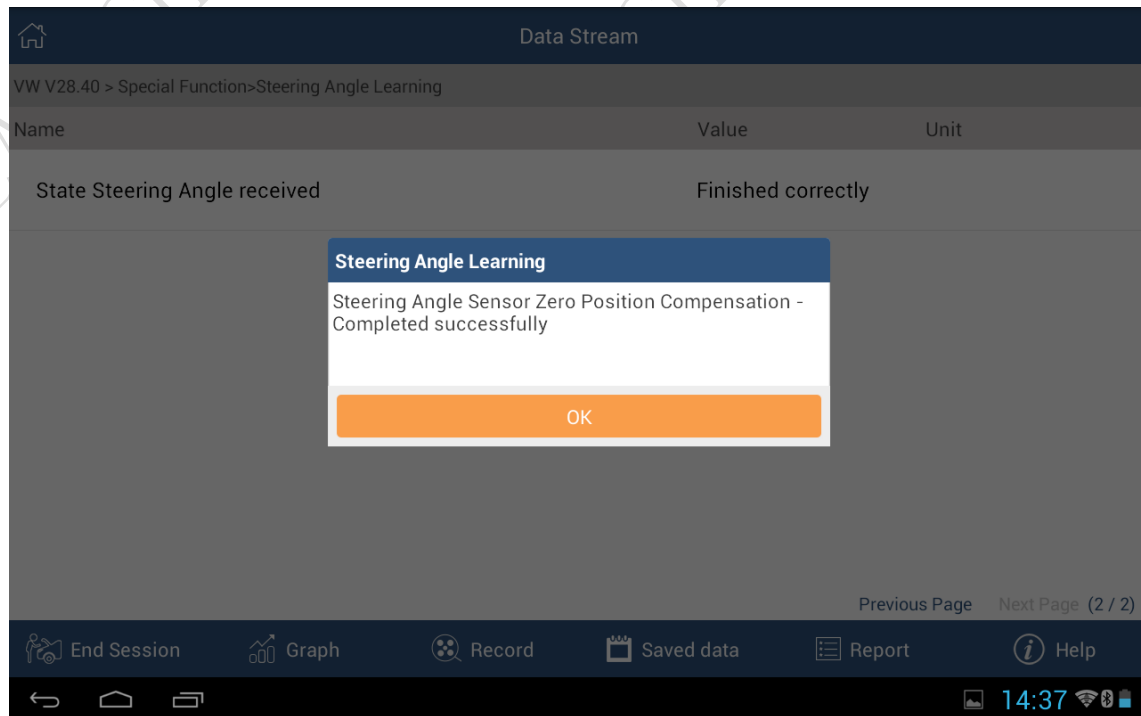
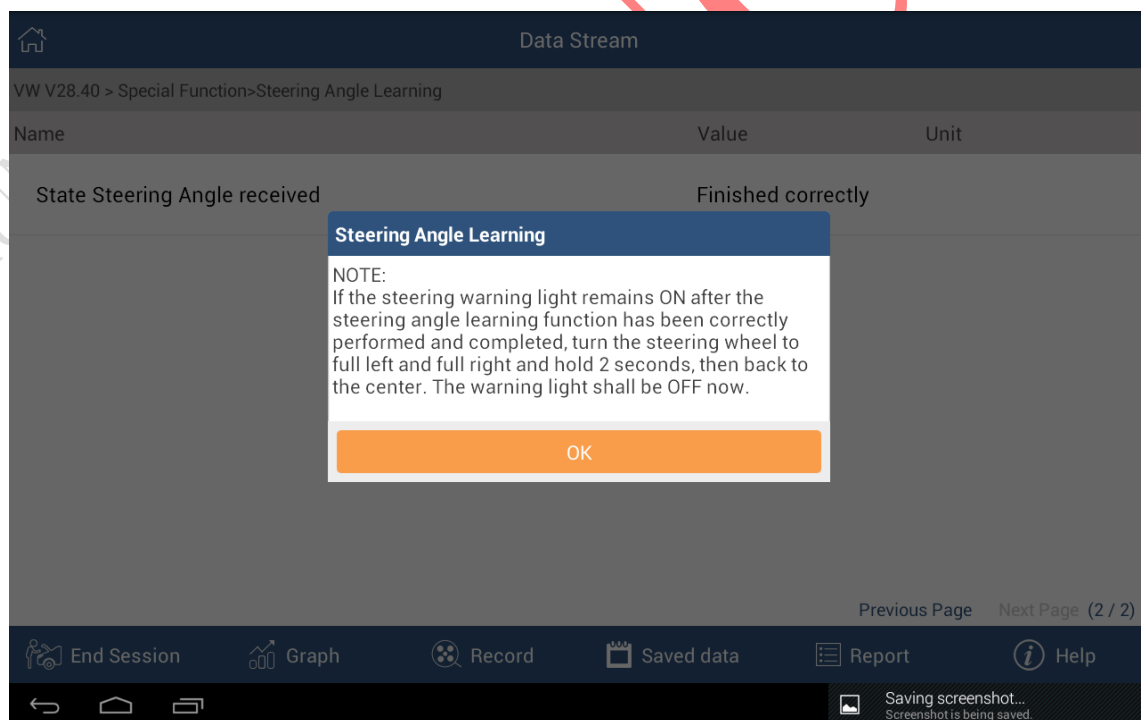
21. If the result shows that the data stream value of “State Steering Angle Received” changed from “In Progress” to “Finished correctly”, then it means the steering angle sensor zero position compensation is successful.

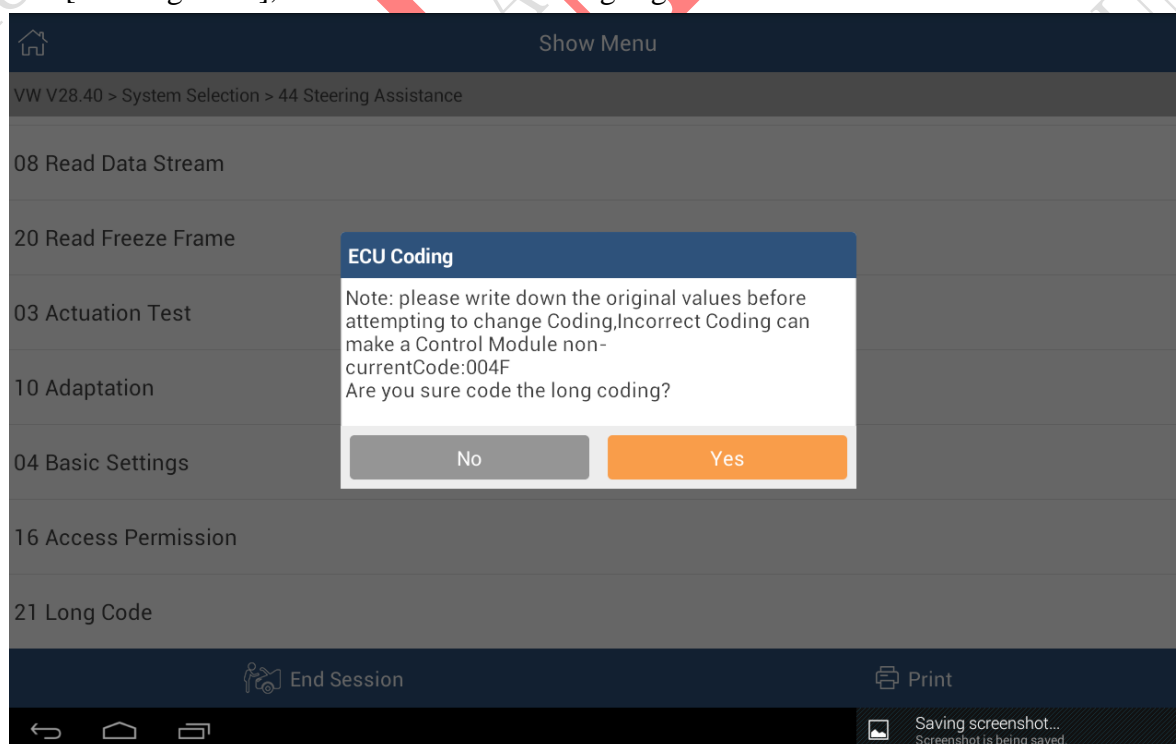
23. For the DTC “U101300 Control module not coded”, manual coding of [44 Power Steering System] will be needed. After entering the 44 system, first we should perform [16 Access Permission]. The password is 10608. The method of logging in is the same with that mentioned in procedure 3. After successful login, select [21 Long Code], as shown in the following Figure. Select “Yes” button.

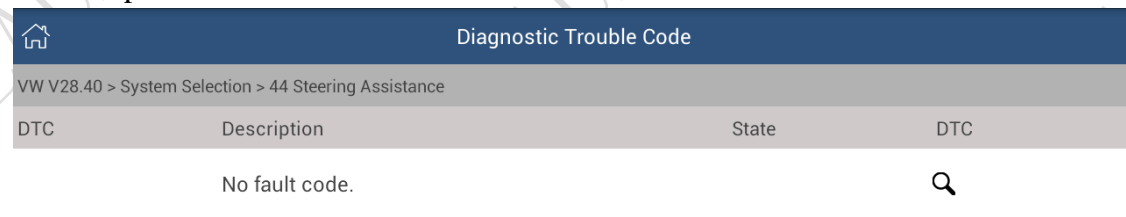
25. Read DTC again after finishing the above operations. If there is no DTC, the malfunction indicator lamp will go out as well, which means the operation is completed.

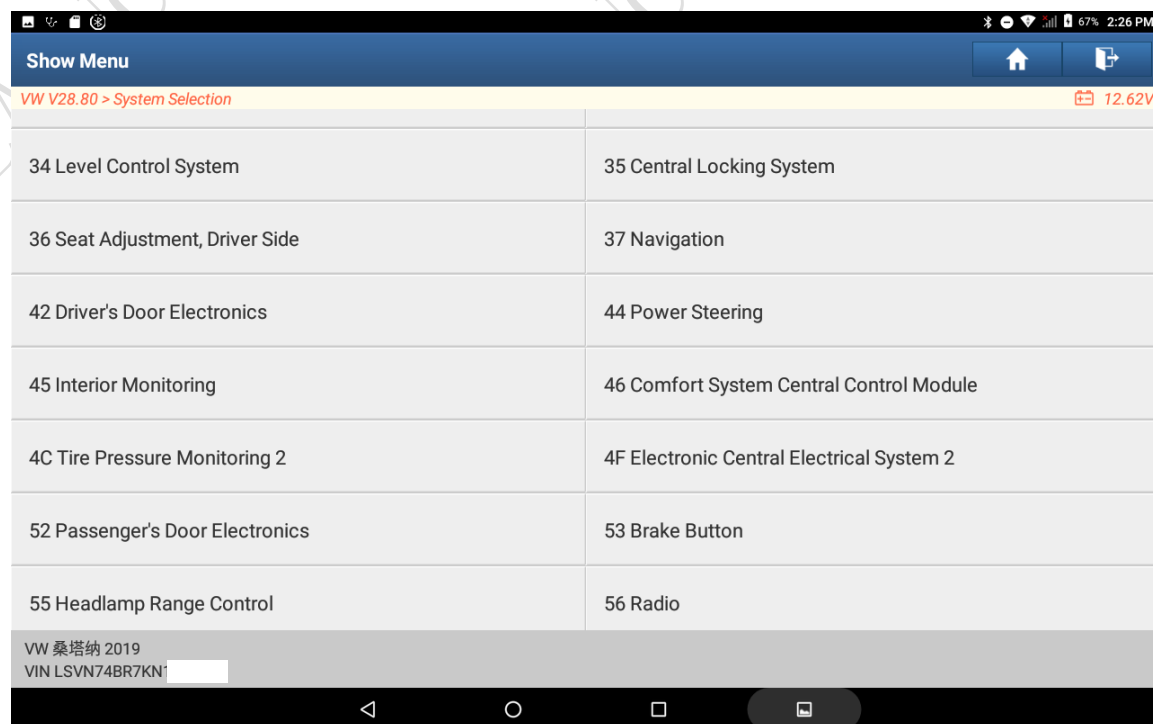
2. Click to enter [System Selection], and then choose [44 Power steering] system.

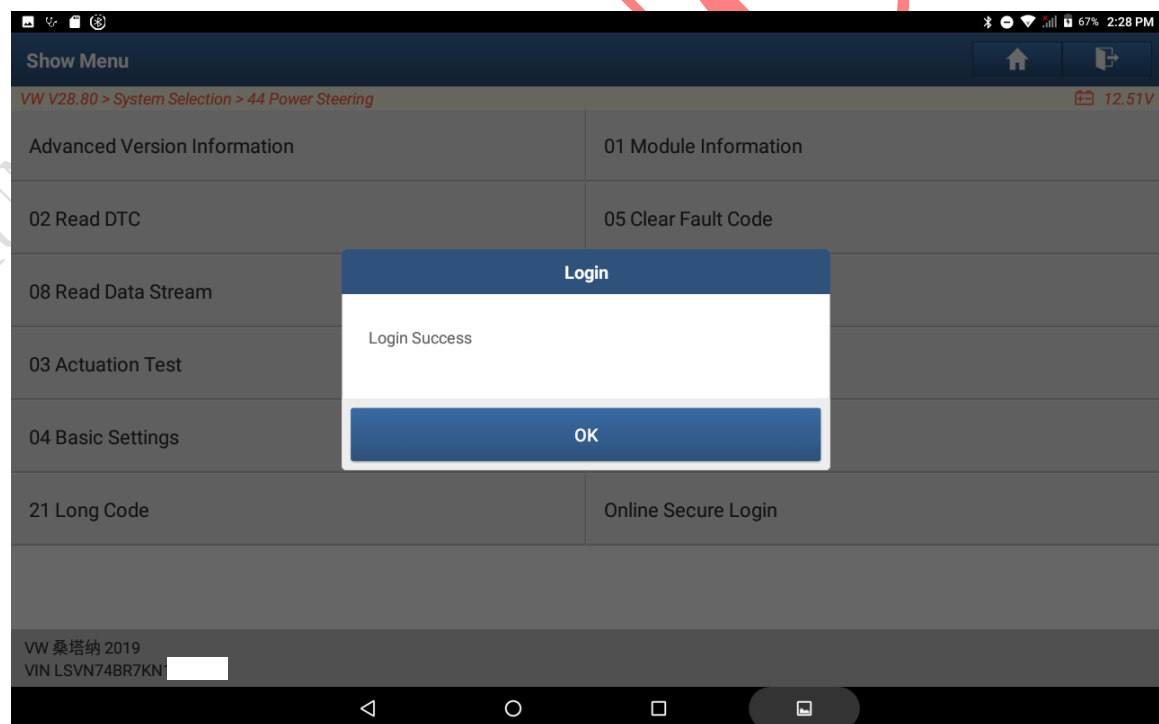
3. The following functions are displayed after entering the 44 Power steering system. First choose [16 Access Permission]. The password is 19249. Click OK after successful login.

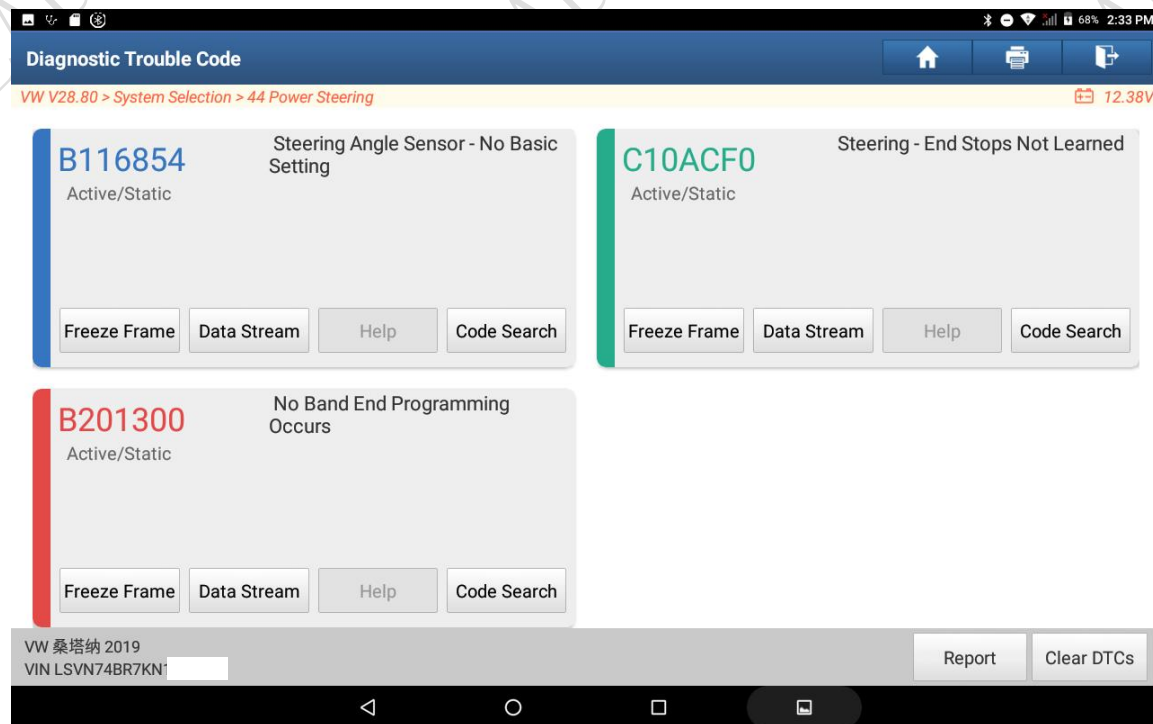
- After completely performing “Reset to factory setting”, “44 Power Steering System” will store the following DTCs. Perform the next steps to clear these DTCs.

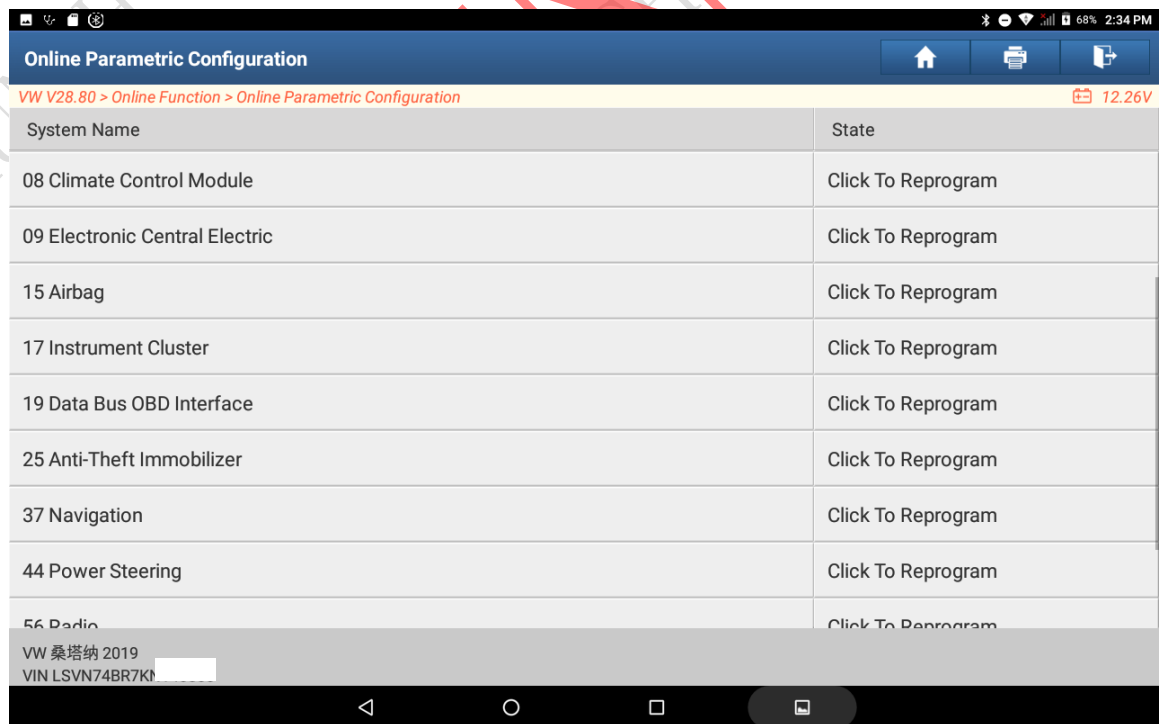
7. The following system list will show up after clicking OK.

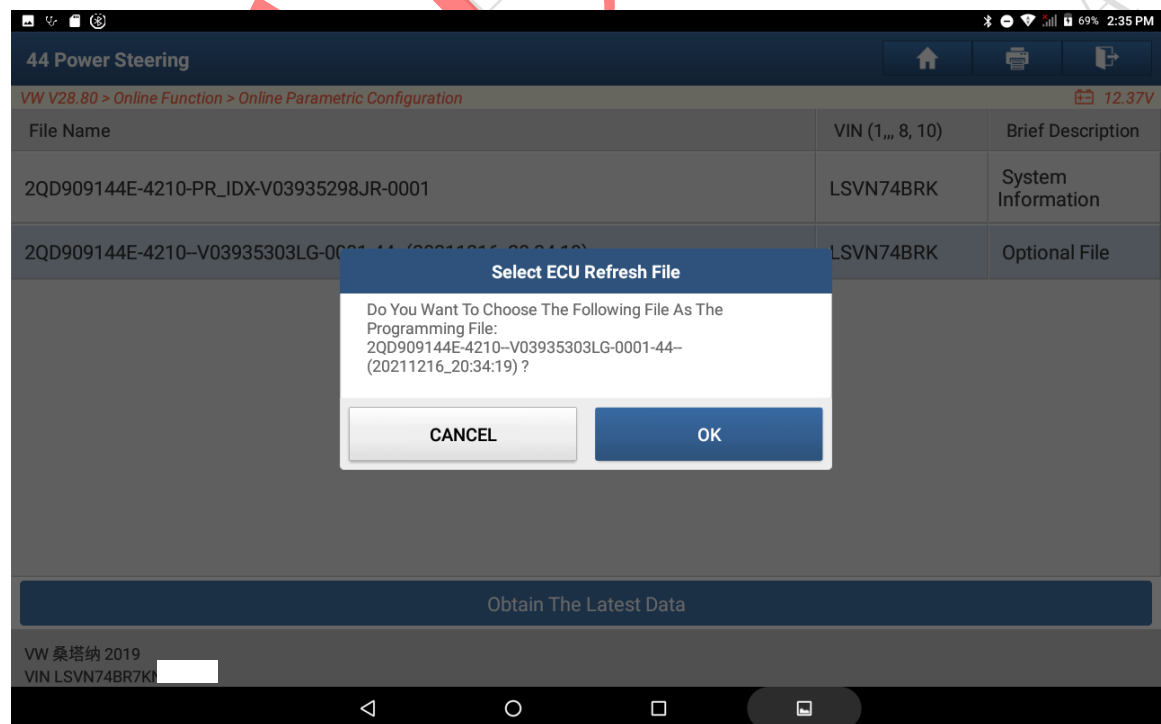
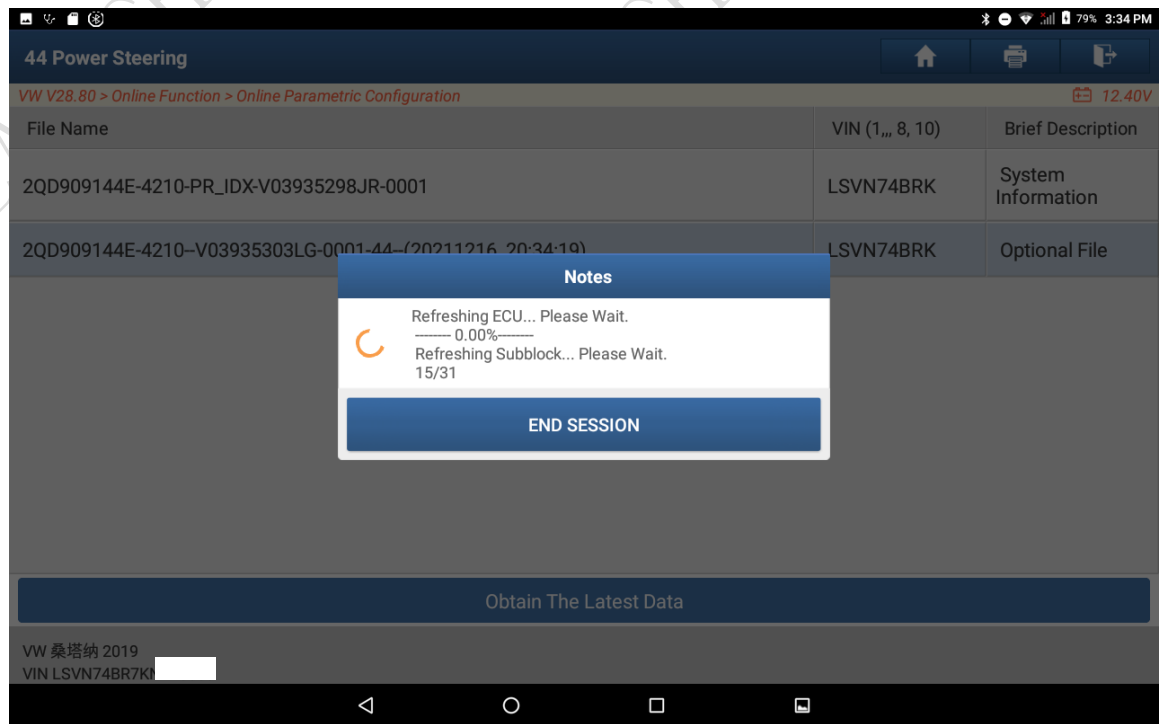
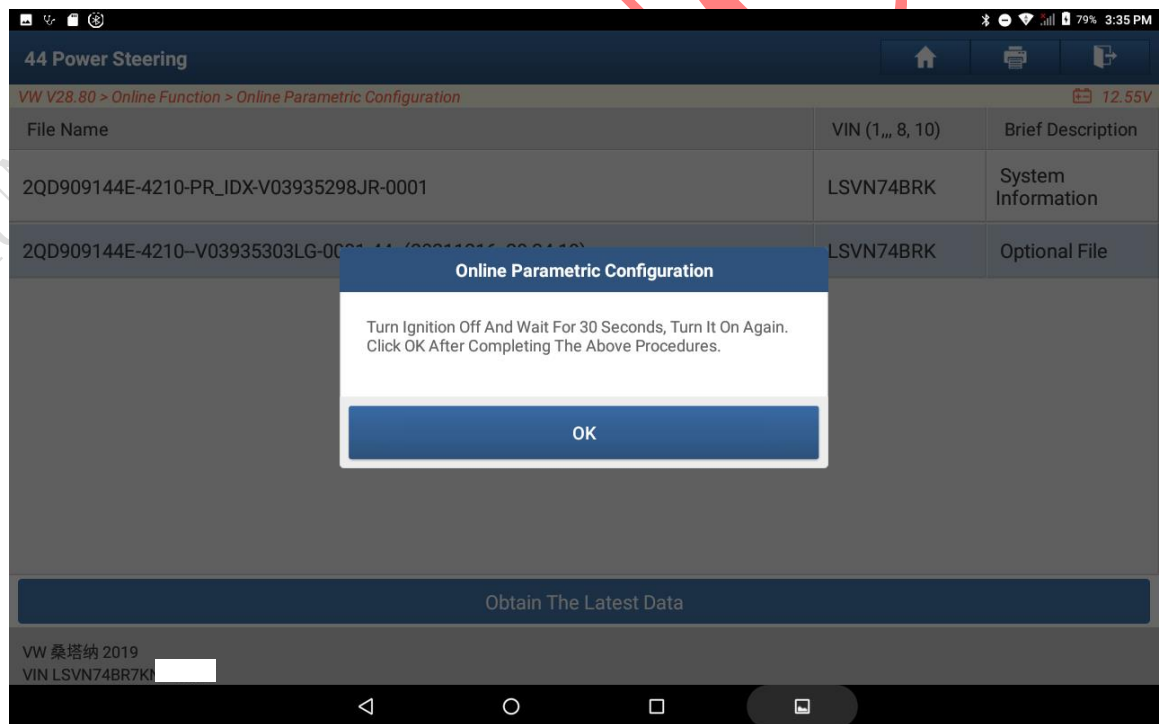
8. Select 44 Power Steering system [Click to Reprogram]. After entering, select one file to reprogram it. After completing [Online Parametric Configuration], you need to switch the ignition off for 30 seconds and then switch it on again. Version information will be read again and now it means the reprogramming is successfully completed. Please note, if the message “safety verification command, verification failed” is displayed during the reprogramming, and then [Online parametric configuration] will need to be performed again.
