Instructions for Replacement of Steering Column

Basic Setting and Software Refreshing of VW NSK Second-Generation Steering Wheel System

Tested Model:

VW, New Lavida 184*/New Gran Lavida/New Cross Lavida 185*, VIN code: LSVNV4188FN0 8****

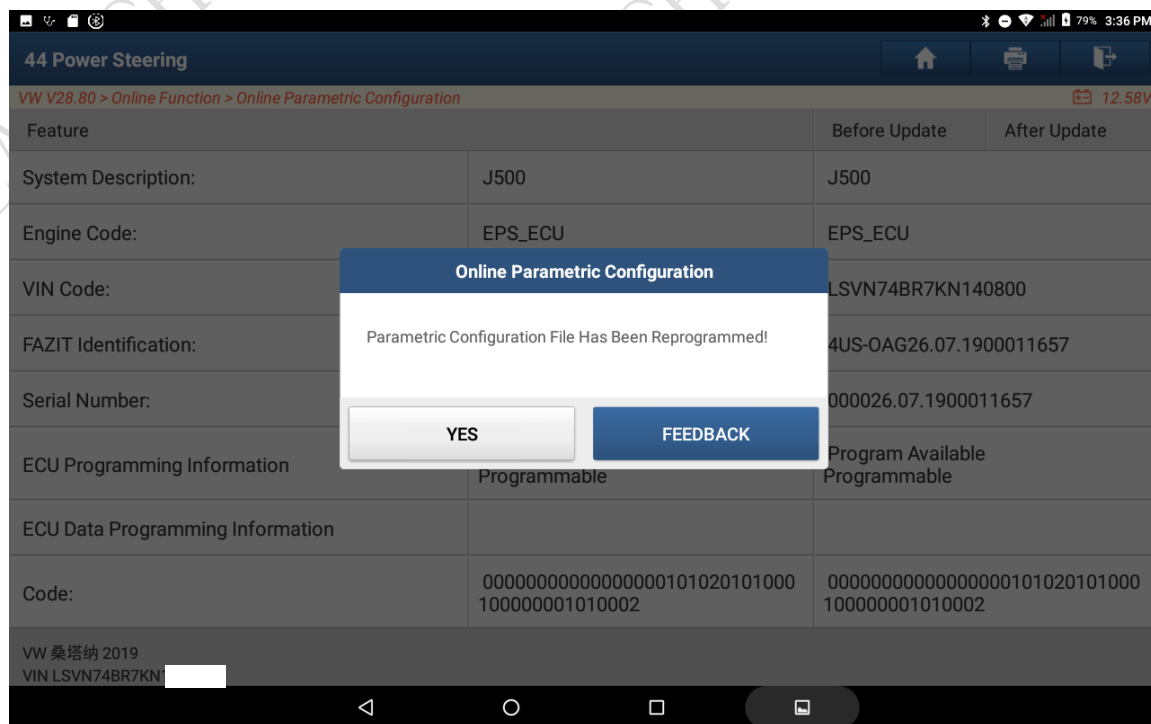
- After performing [Online parametric configuration], please enter 44 system to read DTC again. At this time, an extra DTC “U101300 Control module not coded” will show up. So you need to perform either “Long Code” or “Online Coding” according to the actual situation. Right now the DTC “B201300 No Band End Programming Occurs” may not be cleared, but you can clear it after finishing “Coding”.

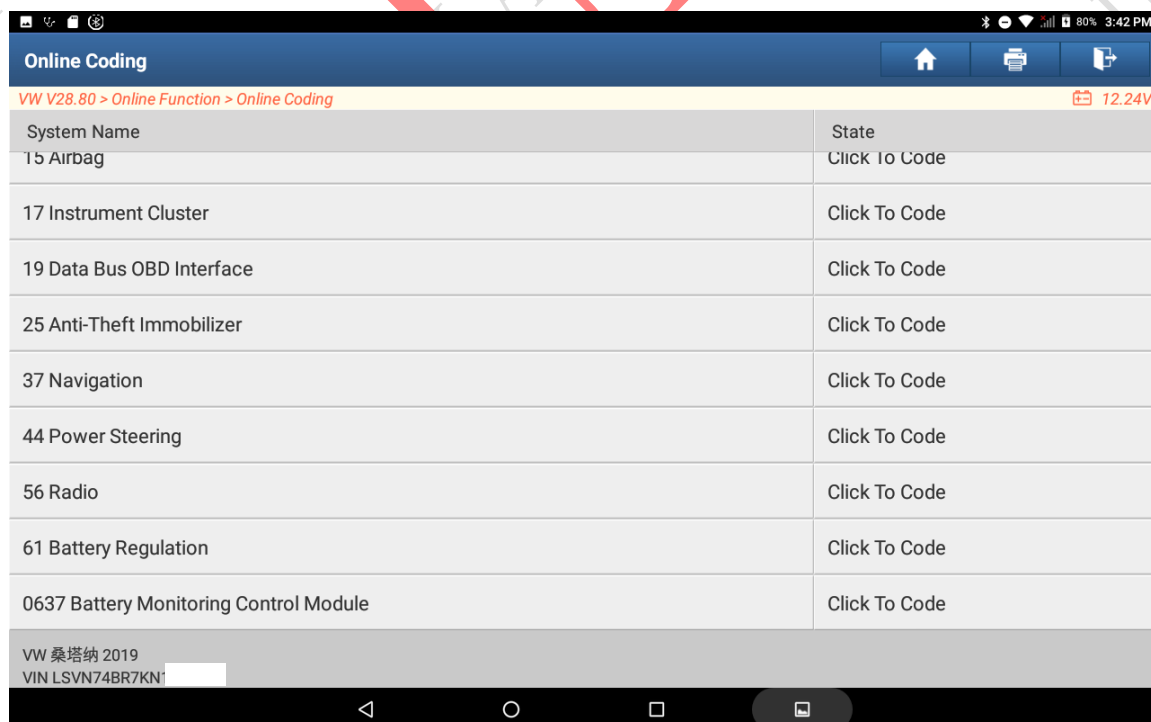
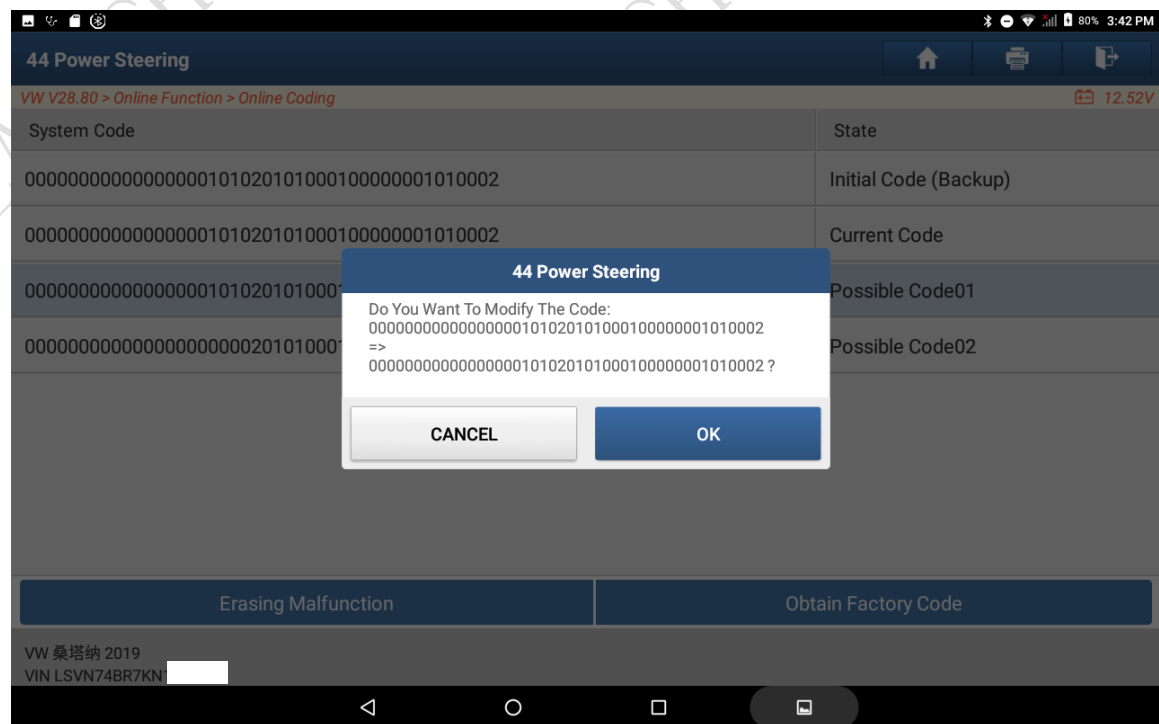
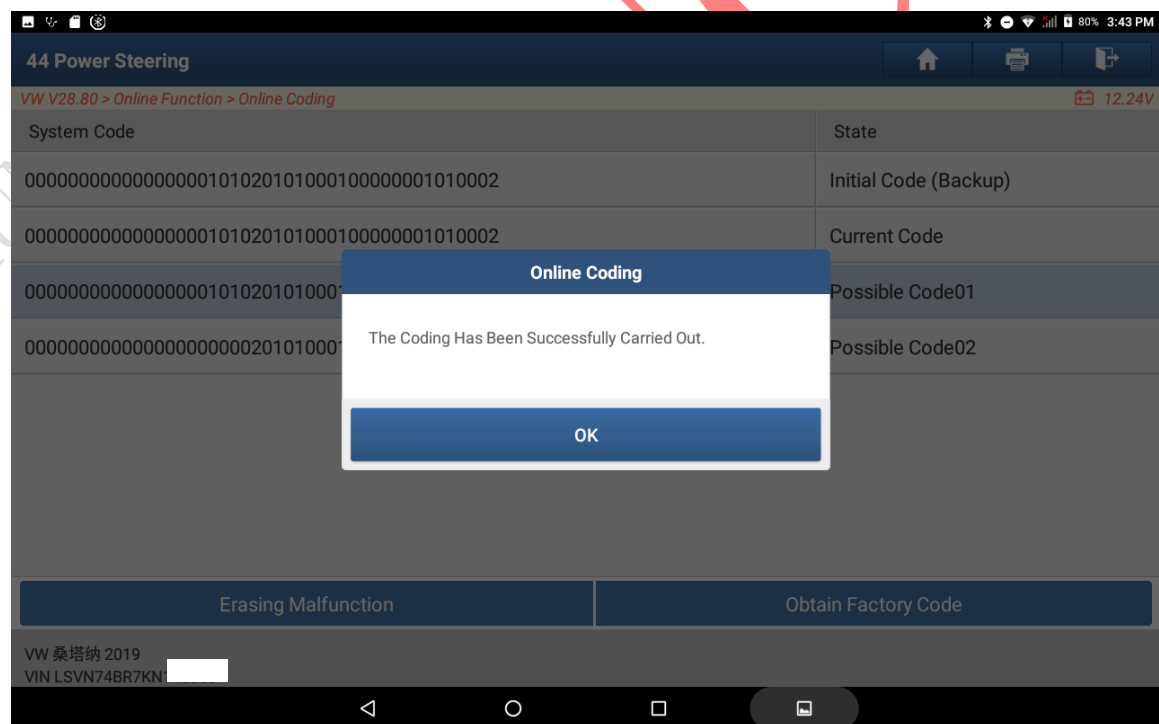
- After entering, select [44 Power Steering] system, and then select one to code from the list that could possibly be coded (for instance: 00000000000000000101020101000100000001010002). When the message “The Coding Has Been Successfully Carried Out” is displayed, and it means the coding is finished.

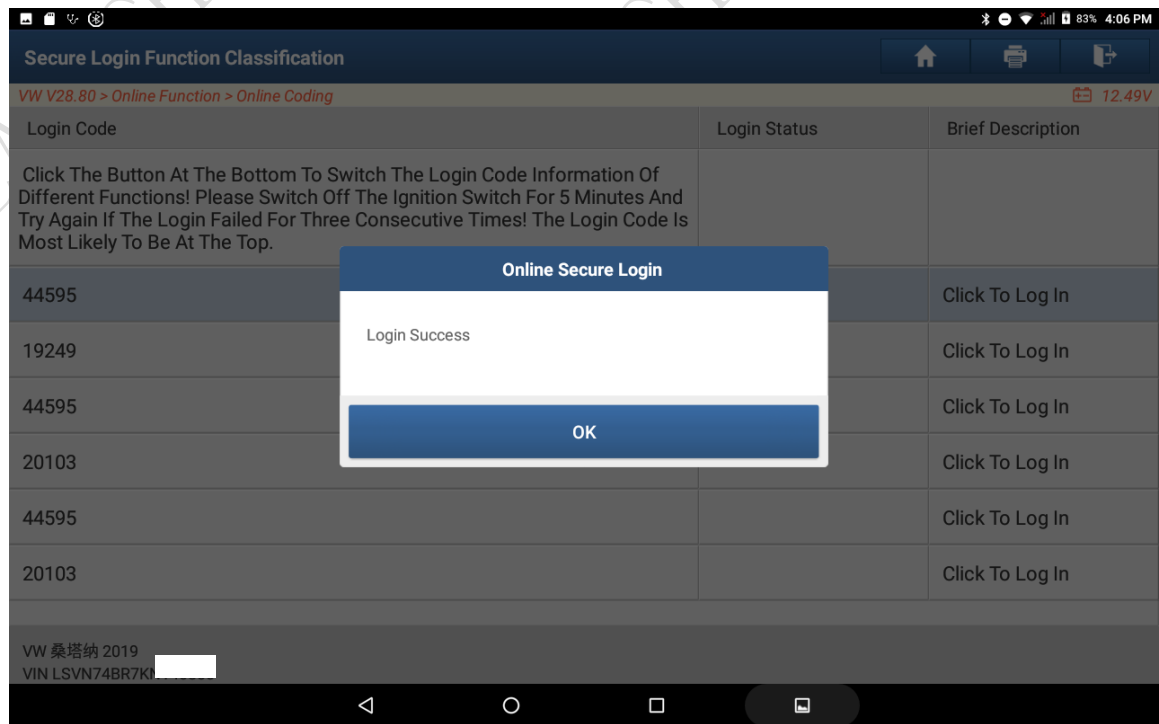
14. During the coding, if it the message “Automatic ‘Security Login’ Failed” is displayed, as shown in the following Figure, please perform [Online Secure Login]. After entering Online Secure Login, please use “44595” to log in. Then please continue the online coding after successful login.

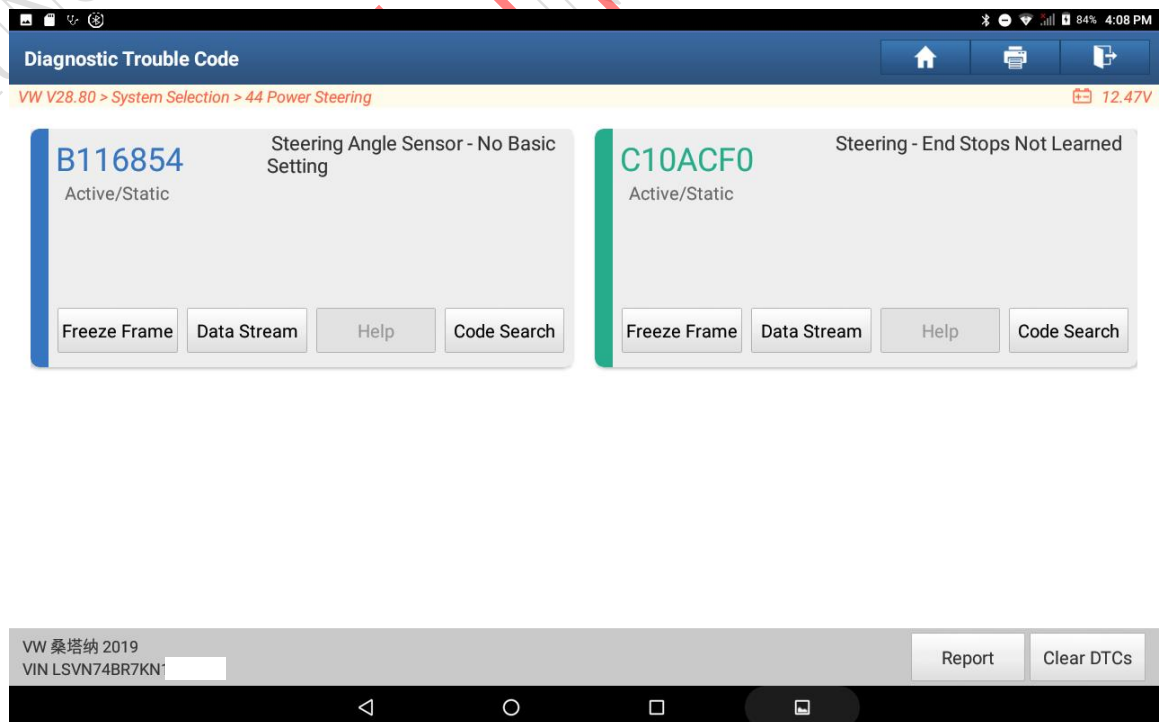
15. Read the DTC again after finishing the coding. At this time, the DTCs “U101300 Control module not coded” and “B201300 No Band End Programming Occurs” have been cleared, but the following two DTCs still exist.

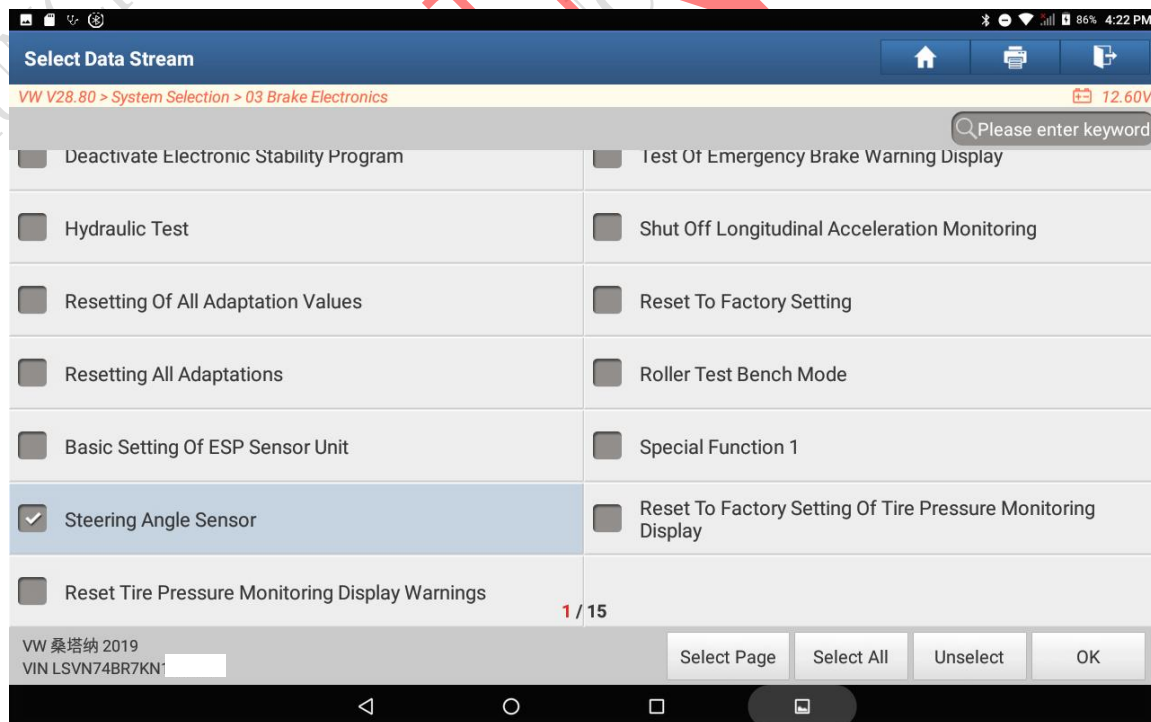
18. After successful login, perform the function of [04 Basic System Adjustment]. Select “Steering Angle Sensor” and click OK.

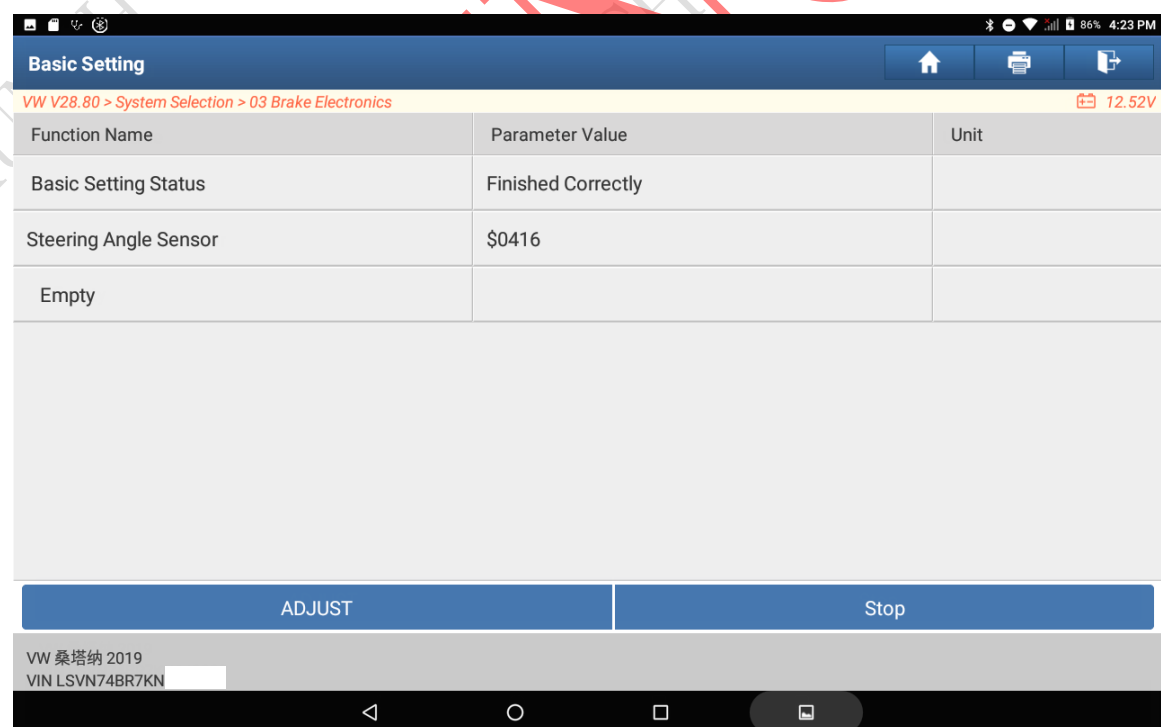
19. Select ADJUST in the following interface. When the status of basic setting changes to “Finished Correctly”, it means the operation is finished.

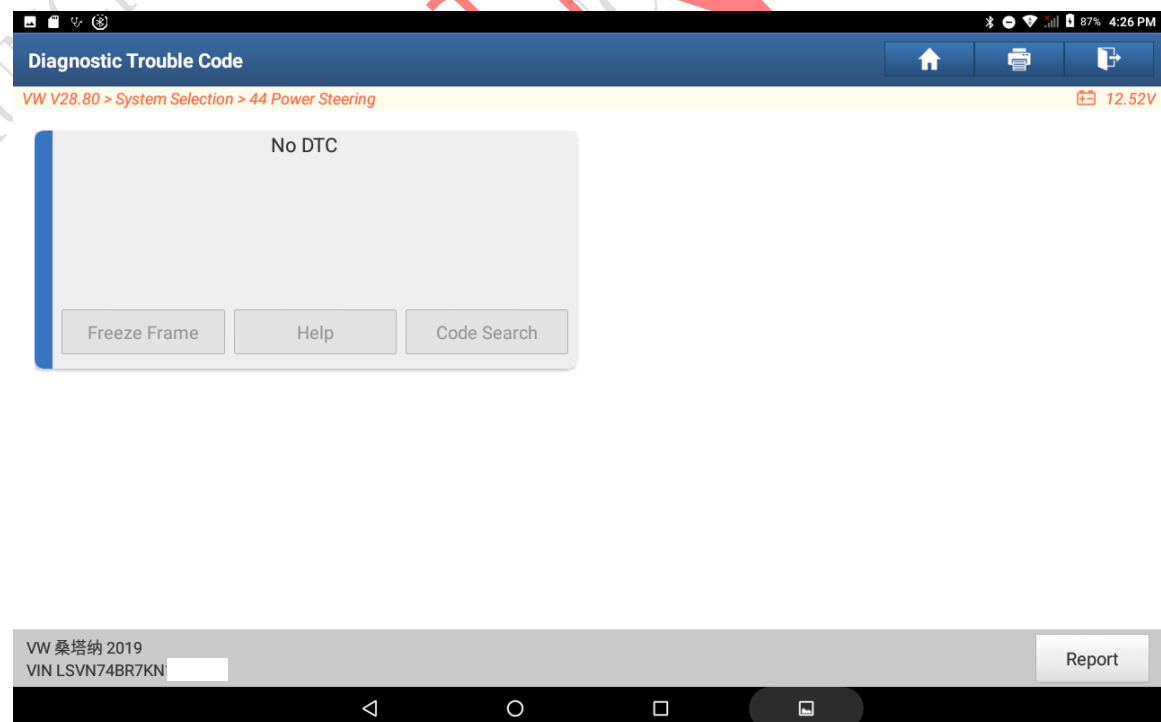
21. Read DTC again after finishing the above procedures. There is no DTC right now and the malfunction indicator lamp will go out as well. The operation is completed.
