Initialization of Rear Right Door Window Motor for 2011 Porsche

- Porsche Cayenne, 2011, VIN=WPIAC2923CLA****, see Picture 1.

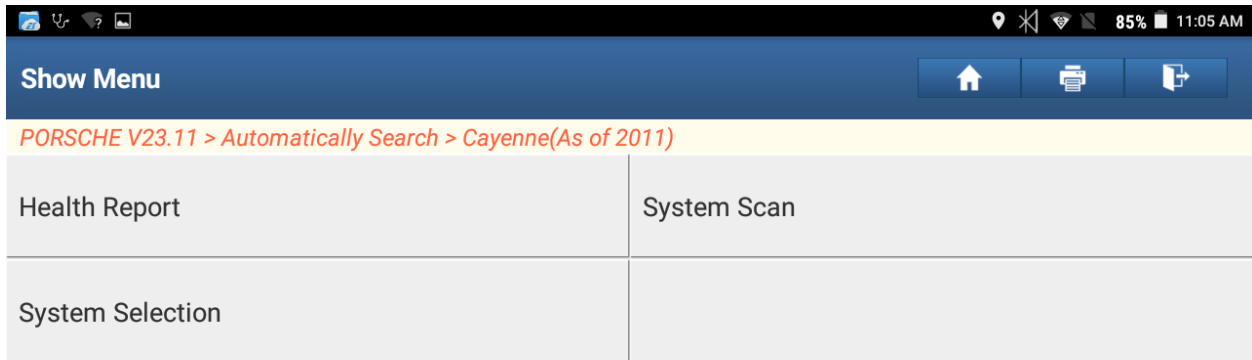
Picture 2

1. Select Porsche Version V21.91 or above.
2. Select fast test, see Picture 2.

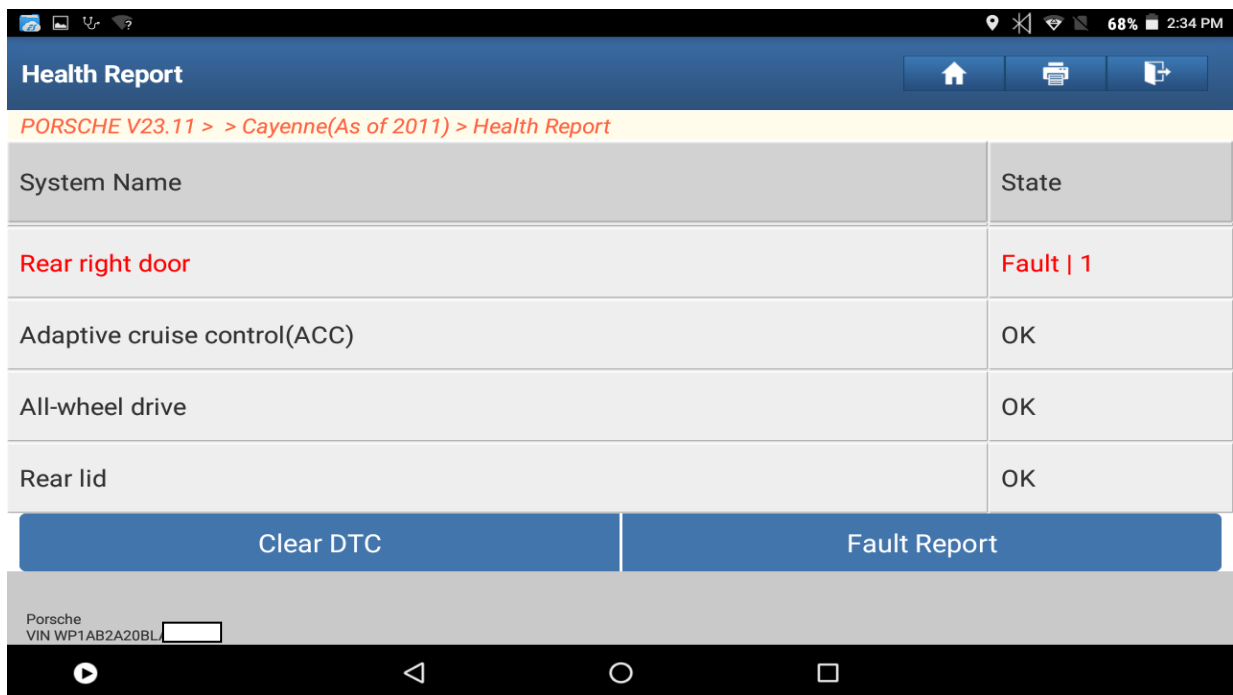
Picture 3

3. Select rear right door, see Picture 3.

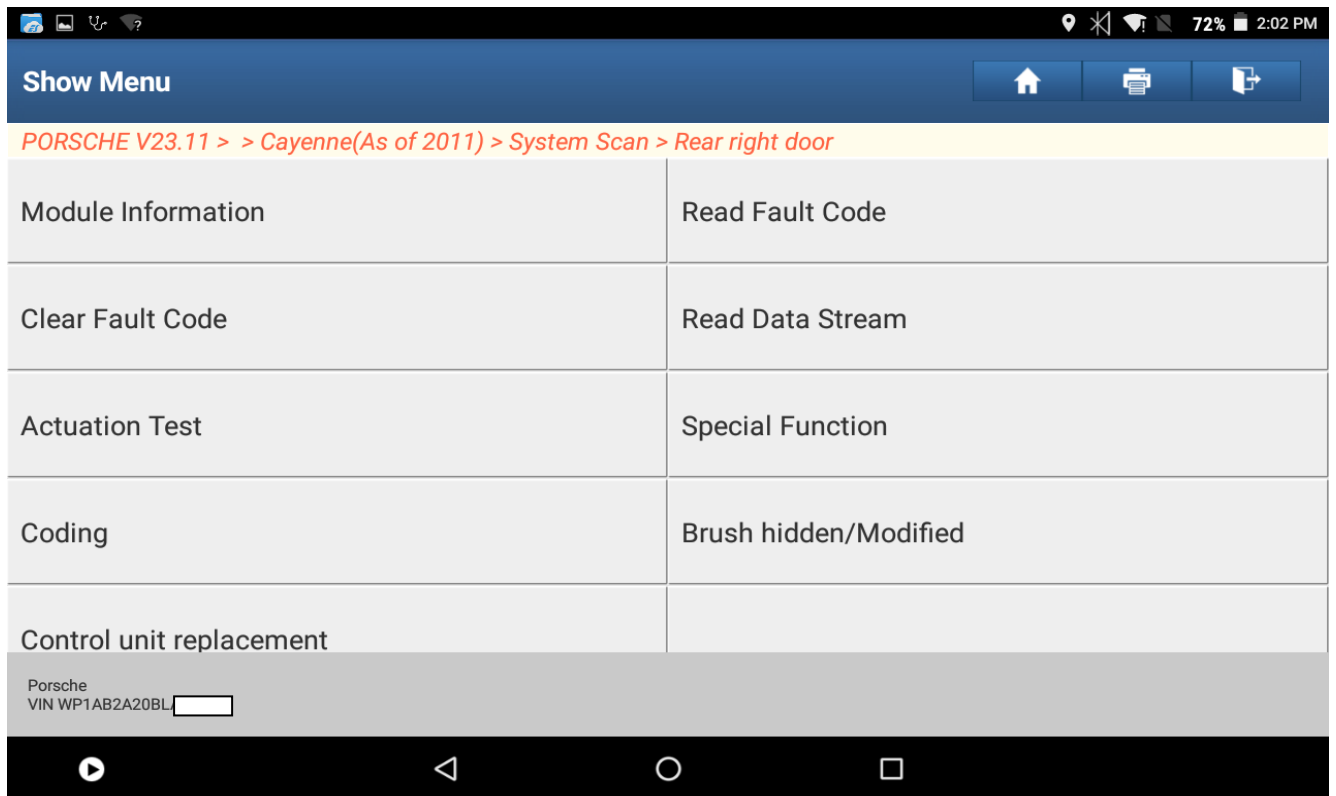
Picture 4

4. Select special function, see Picture 4.

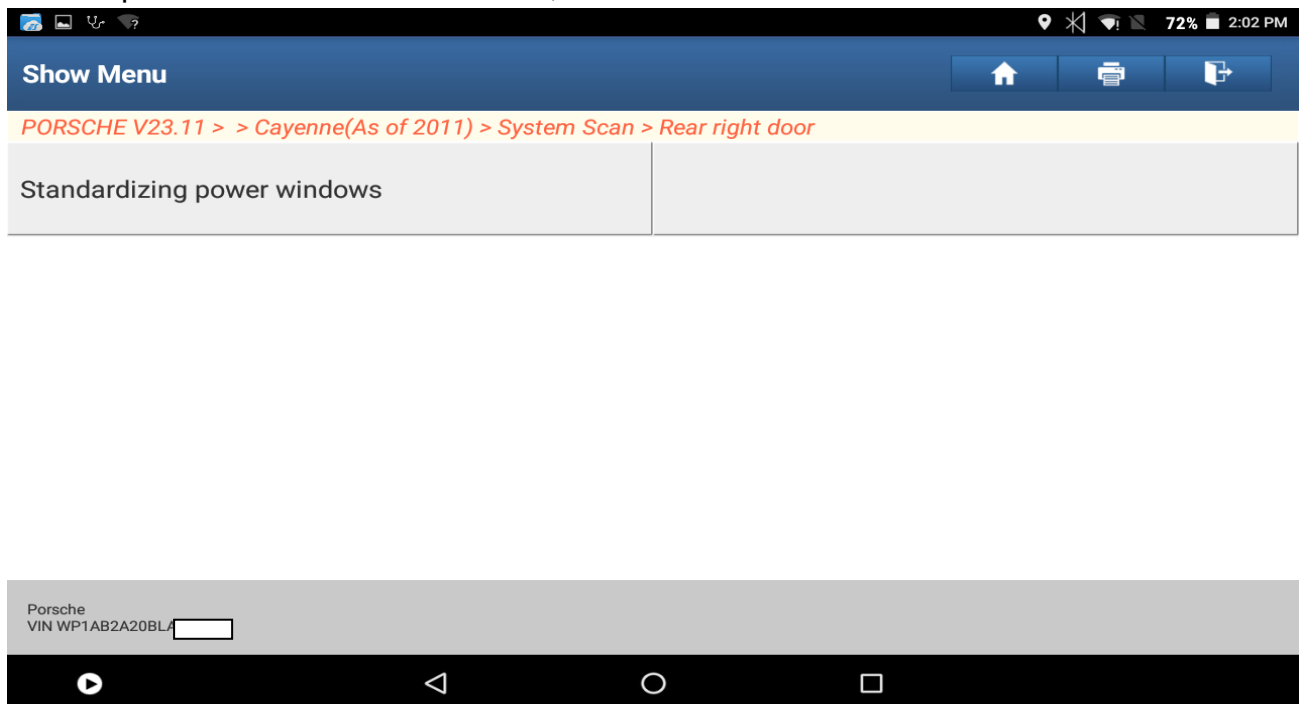
Picture 5

5. Click power window standardization, see Picture 5.

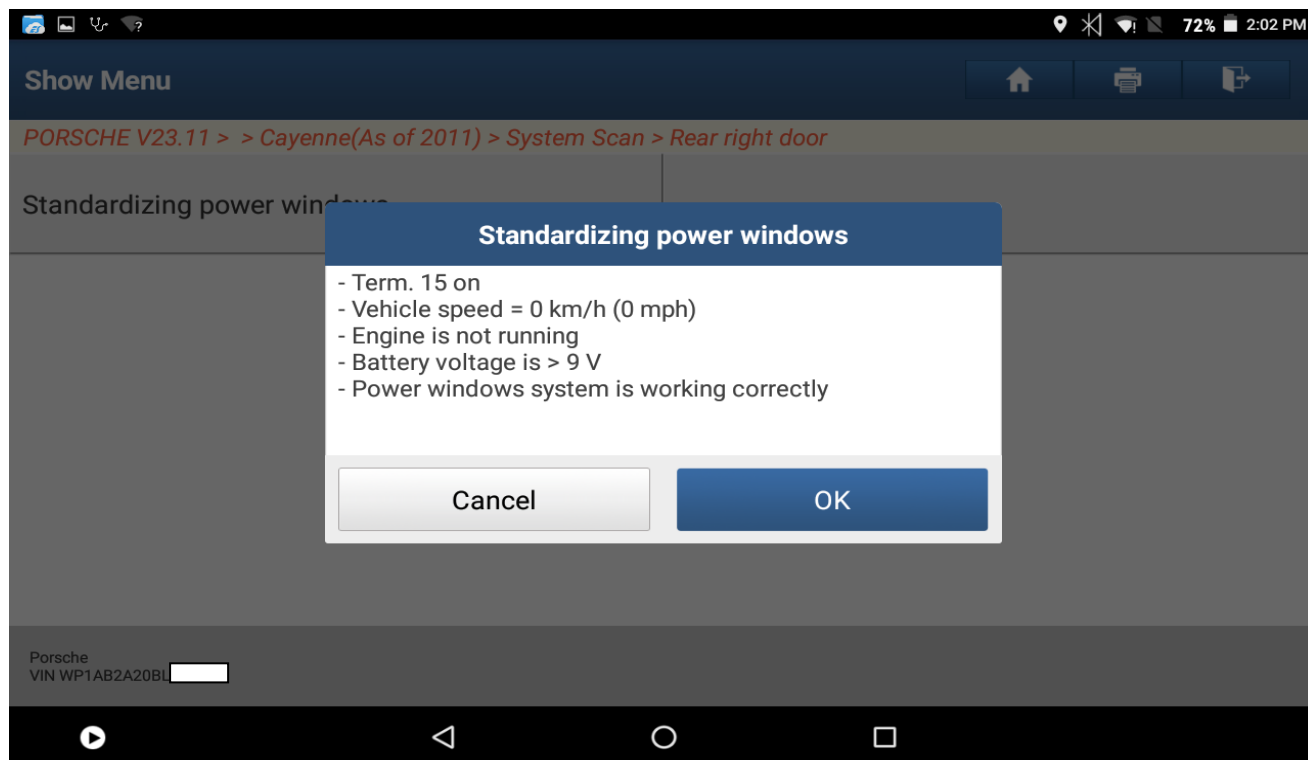
Picture 6

6. It prompts the conditions for standardizing power window: Terminal 15 on, vehicle speed=0km/h, engine not running, battery voltage above 9V, and power window system working normal. After confirmation, click OK, see Picture 6.

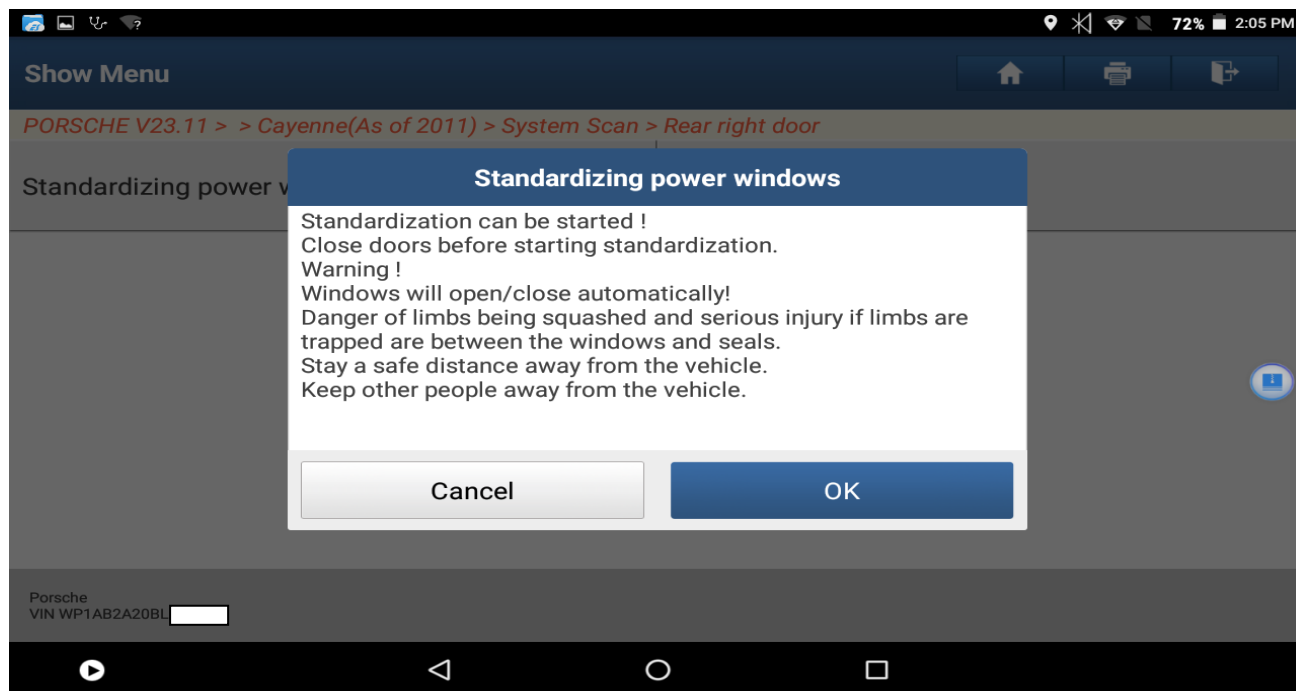
Picture 7

7. It prompts the safety tips for power window standardization. After closing the door and confirming the safety, click OK, see Picture 7.

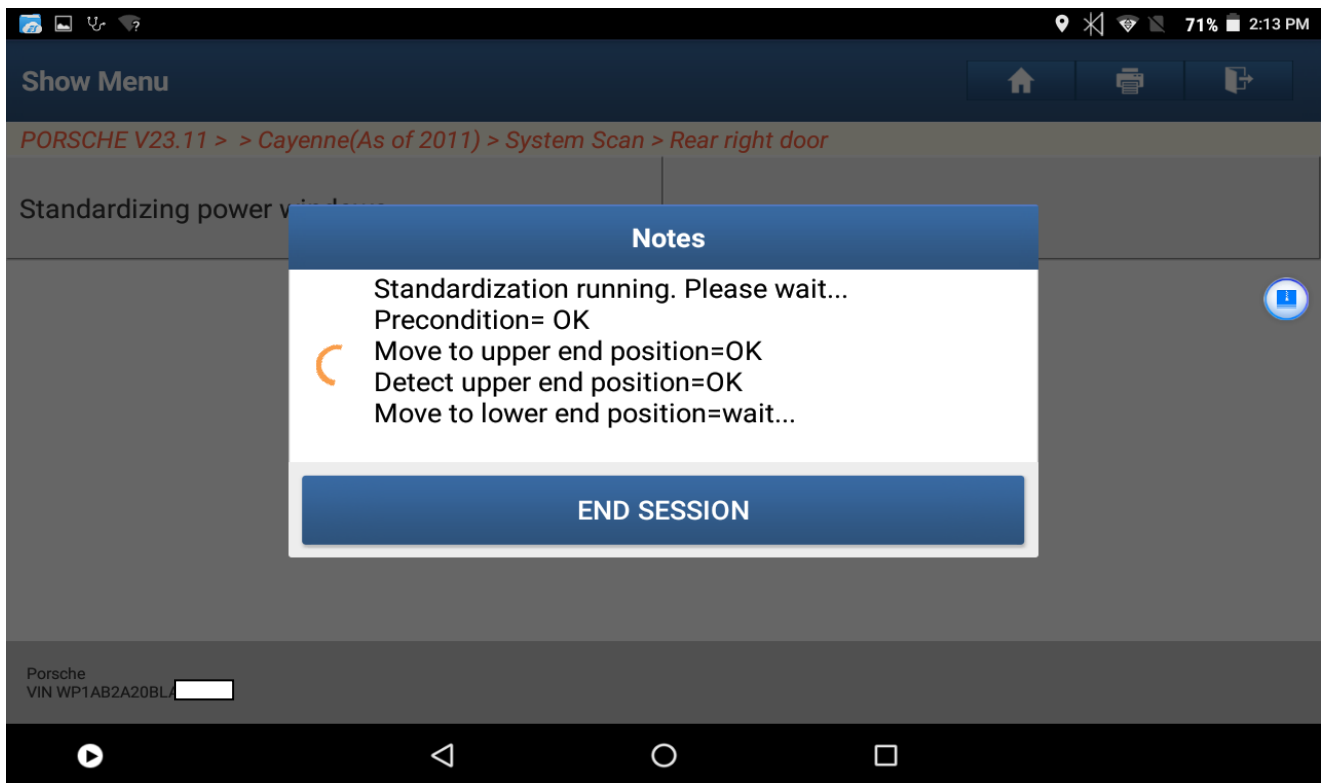
Picture 8

8. It shows standardization in process. Please wait. See Picture 8.

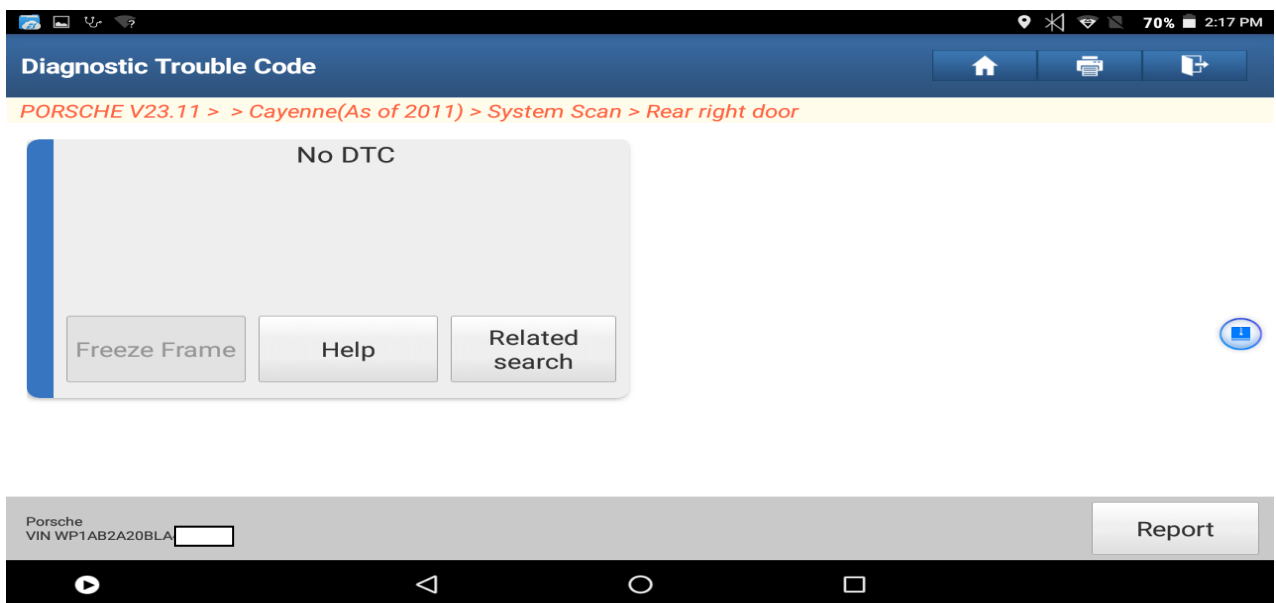
Picture 9

9. In about 1 minute, it shows the power window standardization completed and no DTC is returned, see Picture 9. Troubles are removed and the function is now normal.
