General Service

The General Service is intended to Reset the Service reminder indicator (SRI).

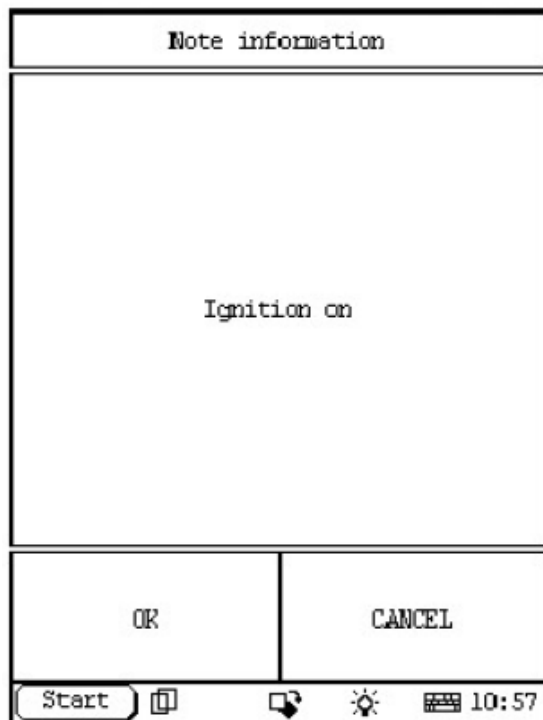
5. step 5: SRI information:

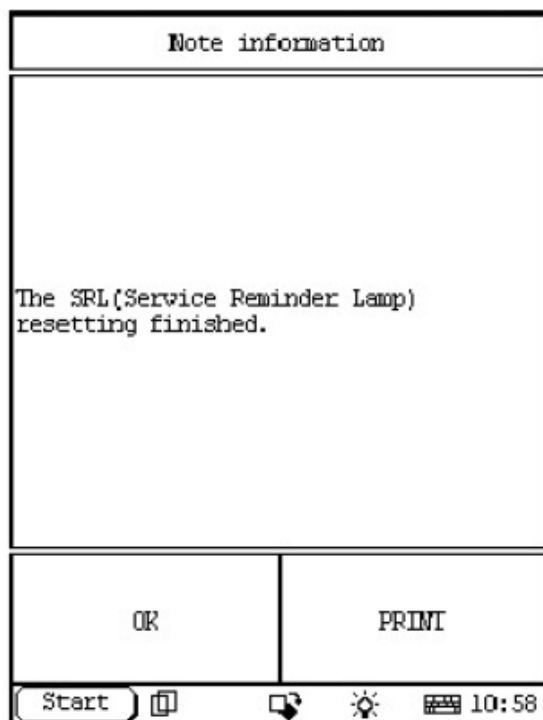
6. step 6: operation result:

If the information displays "The SRL (Service Reminder Lamp) resetting failed", You can try to reset it in the DIM system.
