U0121 ABS-ITM CAN COMM LINE

DTC DESCRIPTION

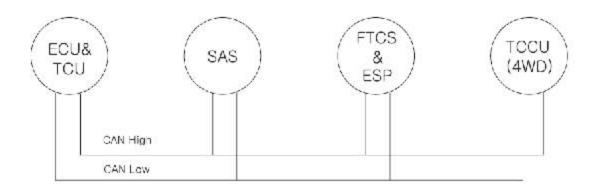
CAN communication is a parallel circuit to interchange information among each units. CAN communication can share much information with units more faster and more efficiently by using specified language.

CAN-High line is twisted with CAN-Low line as a purpose in preventing from a noise. ITM-ECU performs active control by sharing signals of engine RPM, APS, shift position, torque reduction.

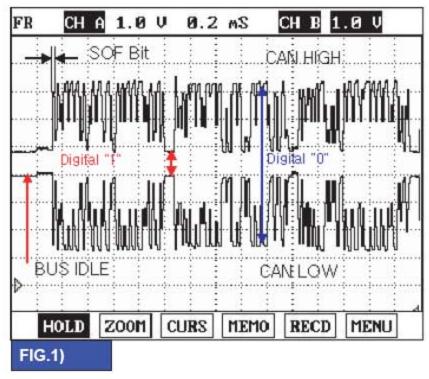
FIG.1) CAN Signal: high & low

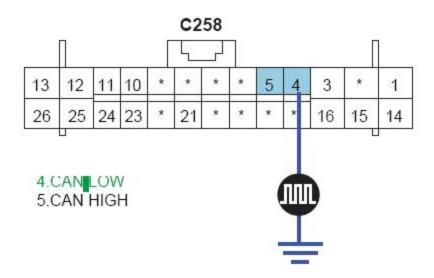
3). Monitor signal waveform between terminal 4, 5 of TCCU harness connector

4). Shift to N Range.

Specification: Signal Waveform & Data

The above value is only for reference.

The actual value may differ from it according to various engine condition.

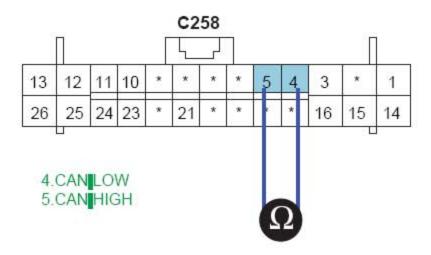
- 1). IG "OFF" & ENG "OFF"
- TCCU connector : Disconnect.
- Measure resistance between terminal "4" of the TCCU harness connector and terminal "5" of the TCCU harness connector.

Specification: Approx. 60Ω

The above value is only for reference.

The actual value may differ from it according to various engine condition.
