## BMW 525Li Sunroof Normalization

**Function description:** sunroof normalization

**Supported products:** Launch PRO or PAD series comprehensive diagnostic equipment

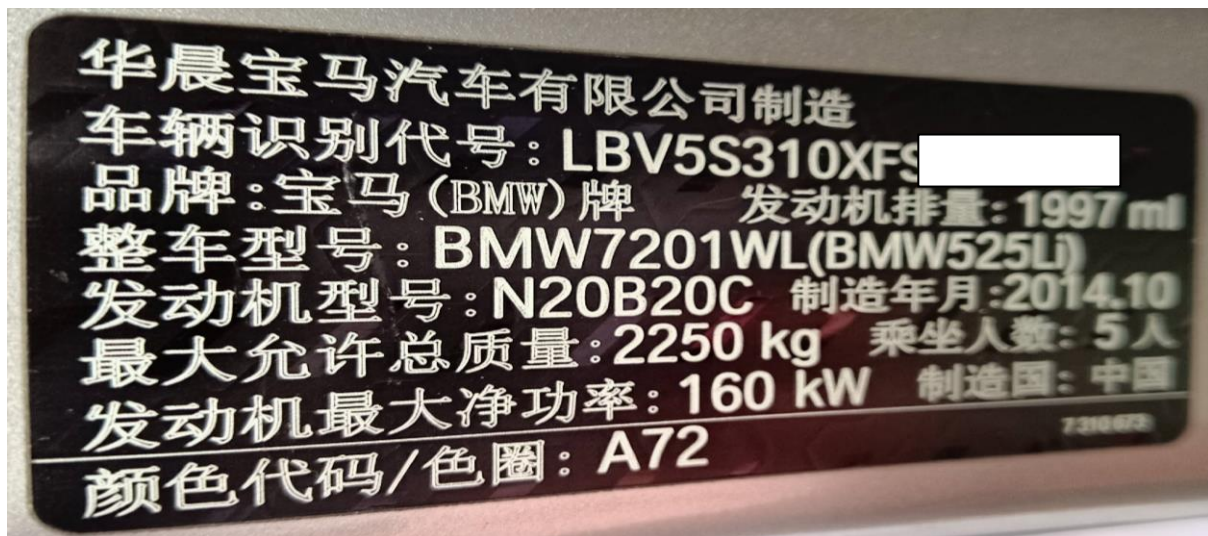
**Tested model:** BMW 525Li VIN:LBV5S310XFSK3\*\*\*\* (see the following figure)

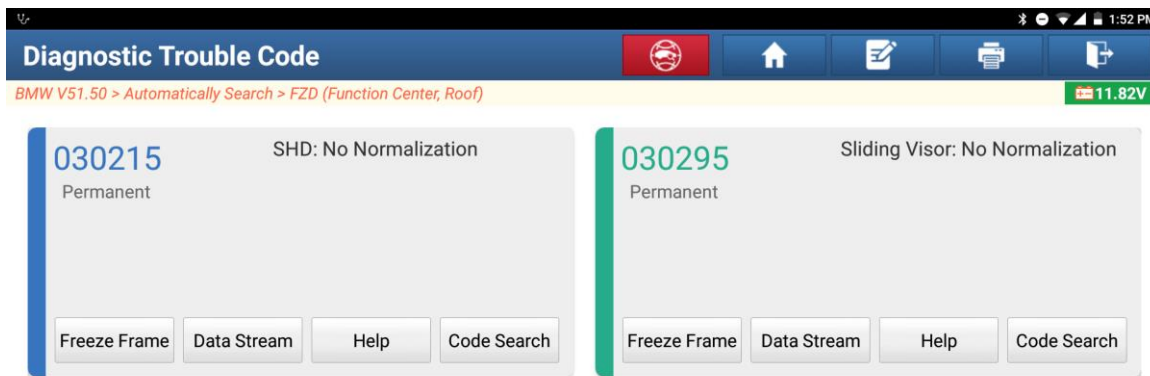
The FZD system reports the following DTC: 030215 SHD: No Normalization. (See the following figure.)
