Maybach S480 Service Reset

Function description: service reset

Supported products: Launch PRO or PAD series comprehensive diagnostic equipment

Tested model: Maybach S480 VIN: W1K6X6BB7MA05**** (see the following figure)

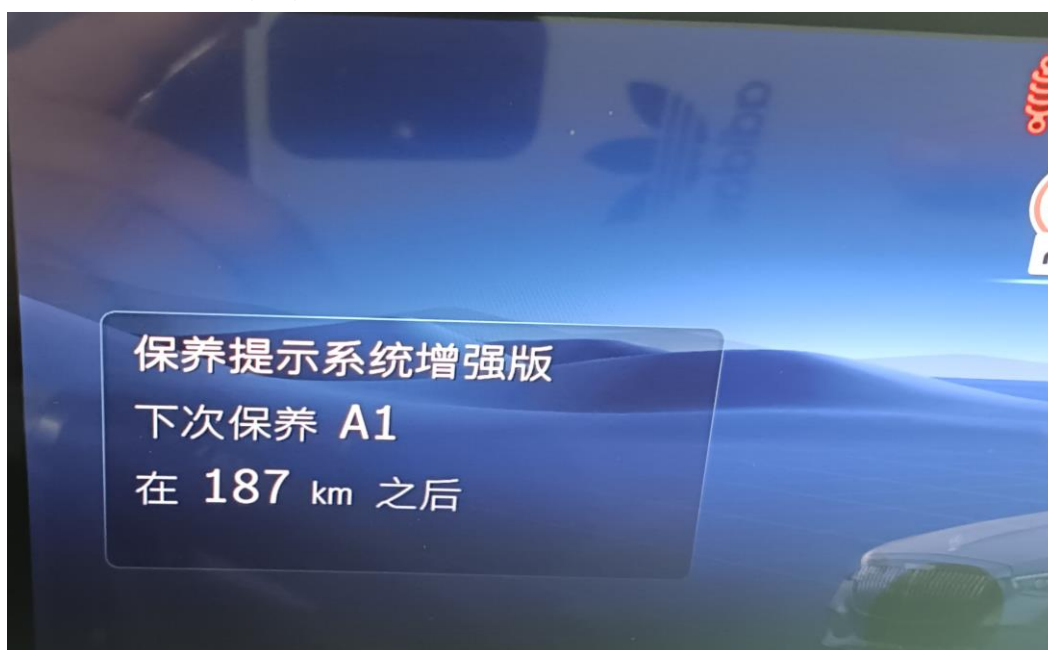
The instrument cluster prompts that the next service A1 will be after 187 kilometers. (See the following figure.)

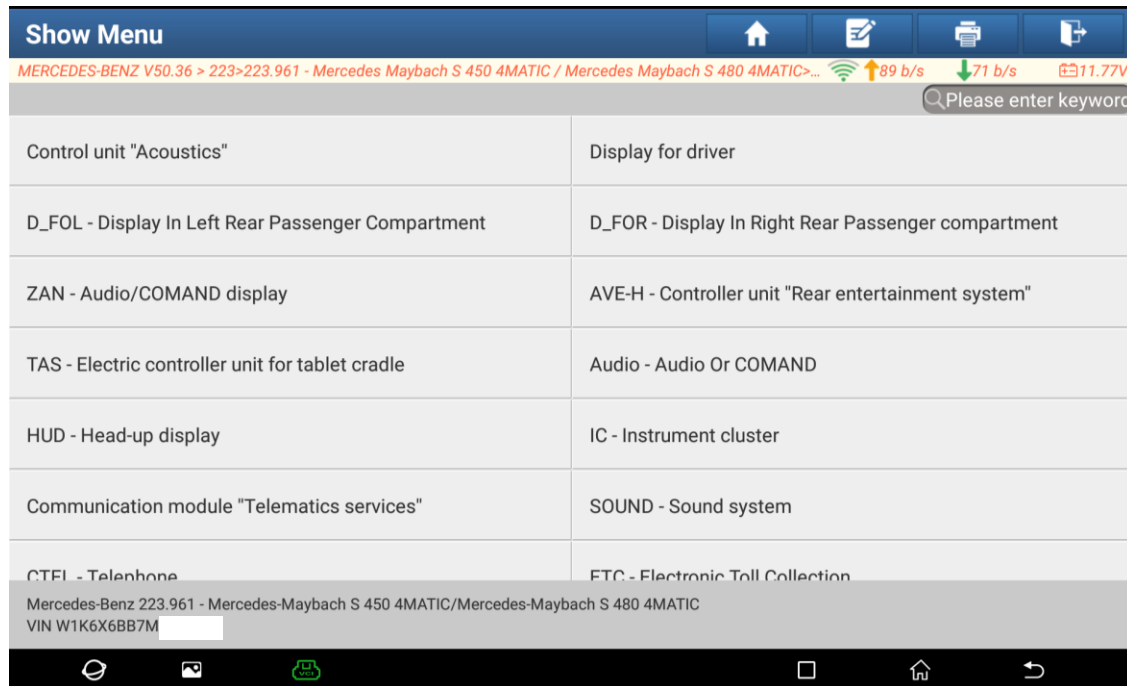
1. Choose [IC - Instrument cluster] to access the system. (See the following figure.)

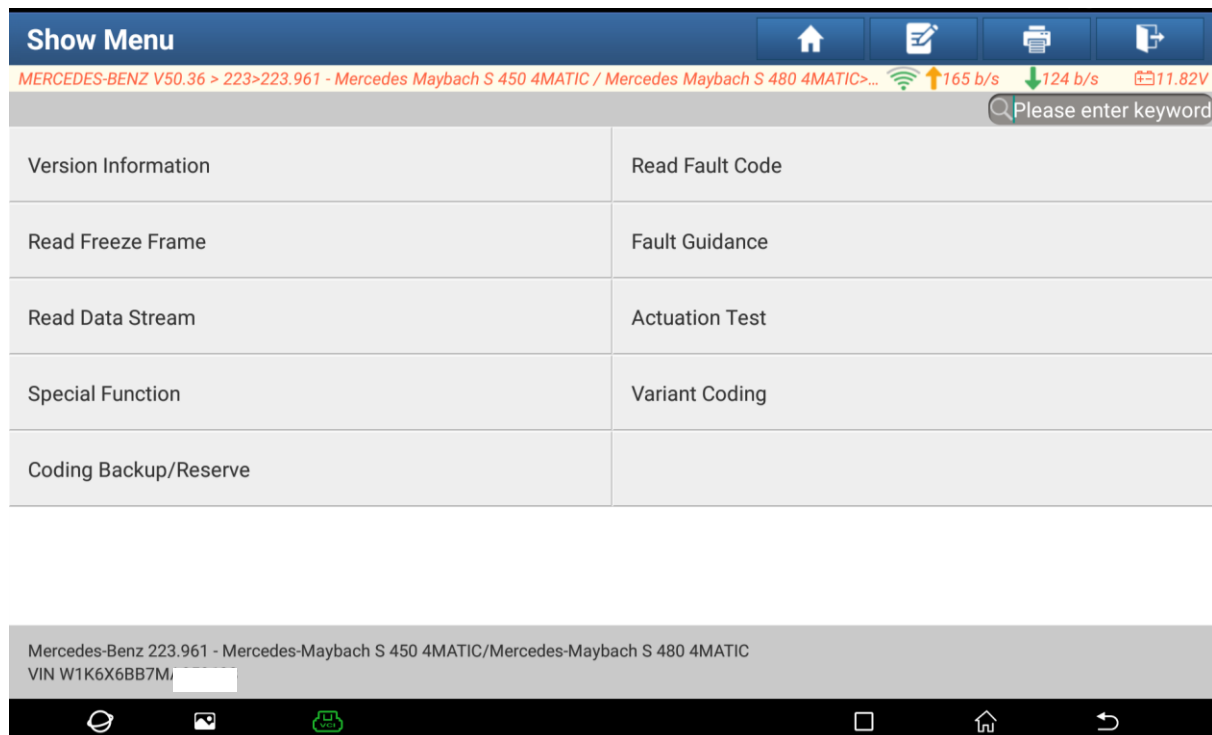
2. Choose [Actuation Test]. (See the following figure.)

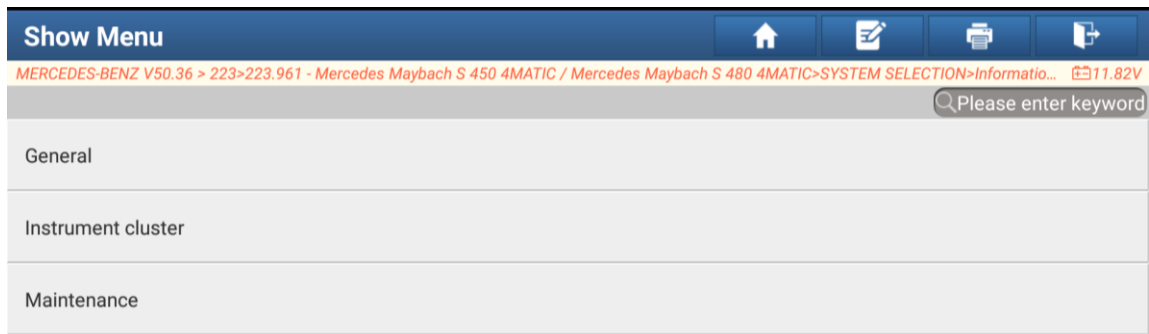
3. Choose [Maintenance]. (See the following figure.)

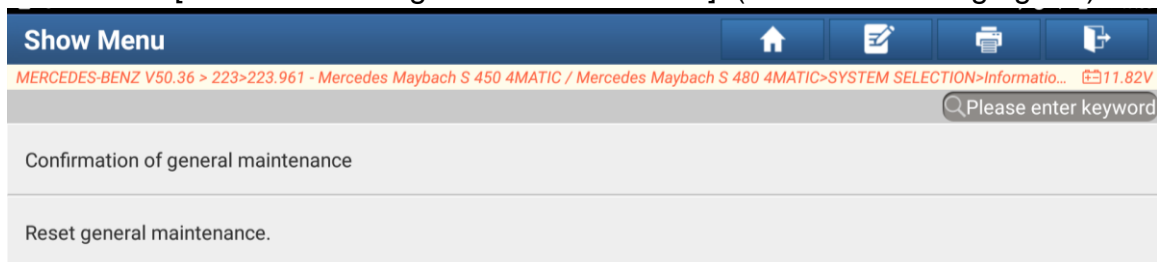
4. Choose [Confirmation of general maintenance]. (See the following figure.)

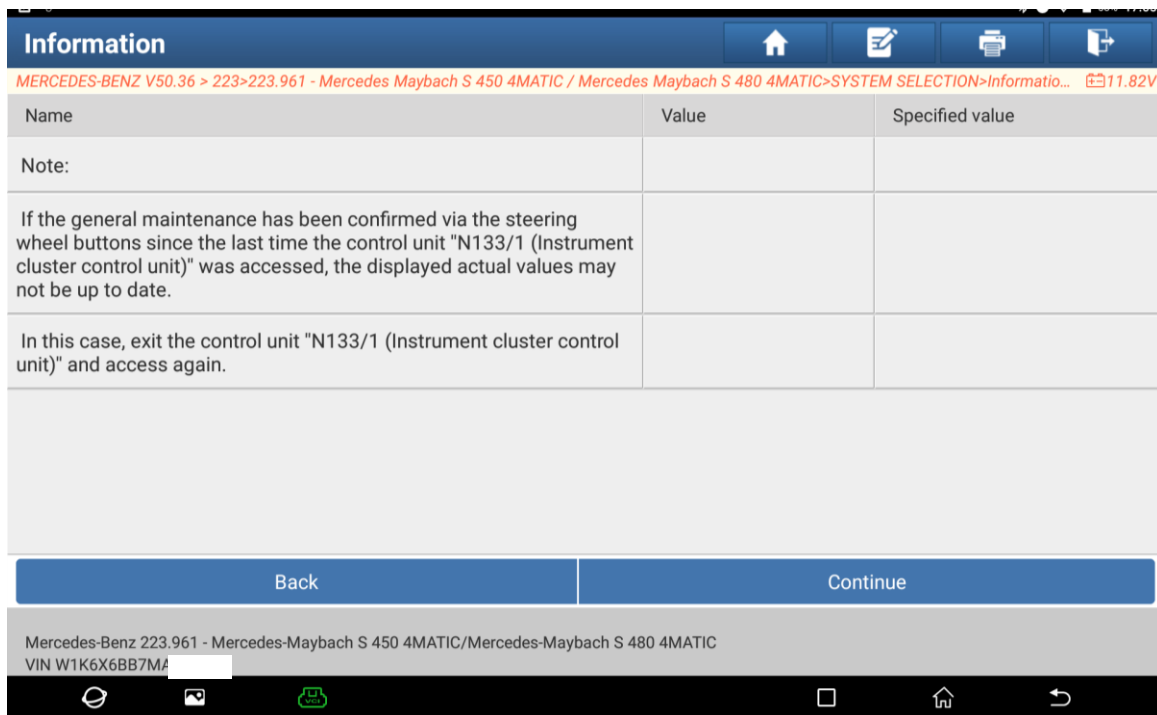
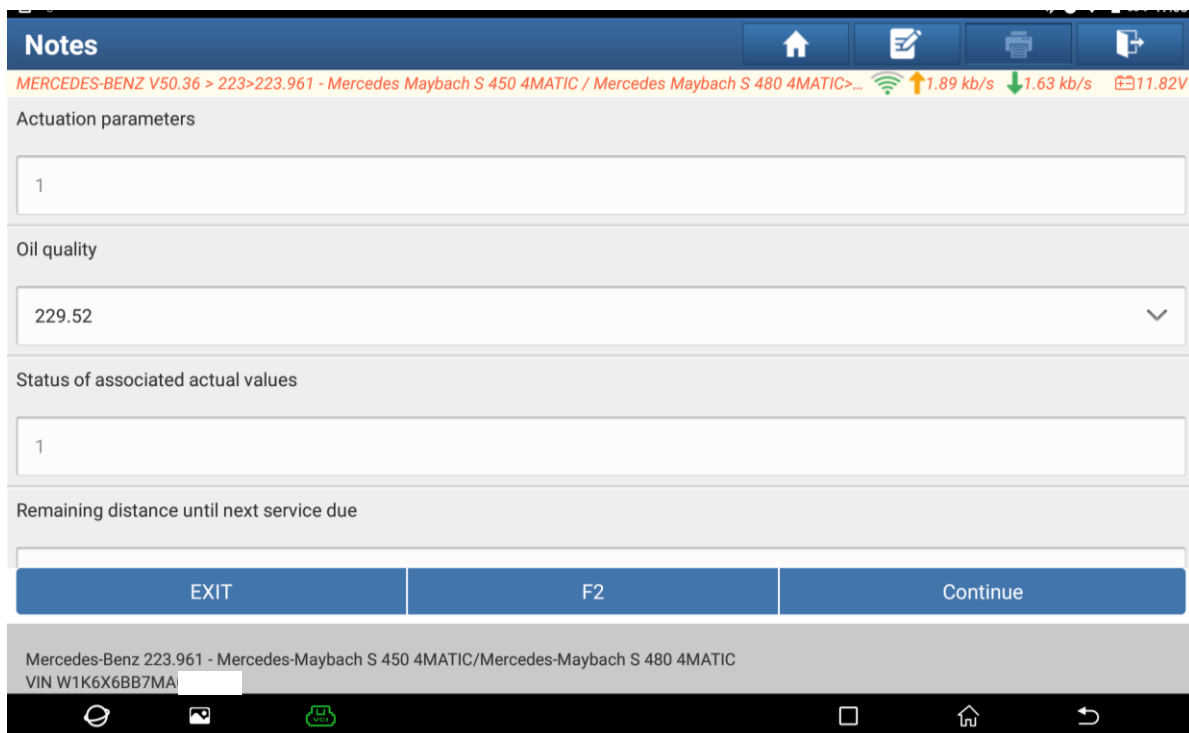
5. Follow the prompts to continue. (See the following figure.)

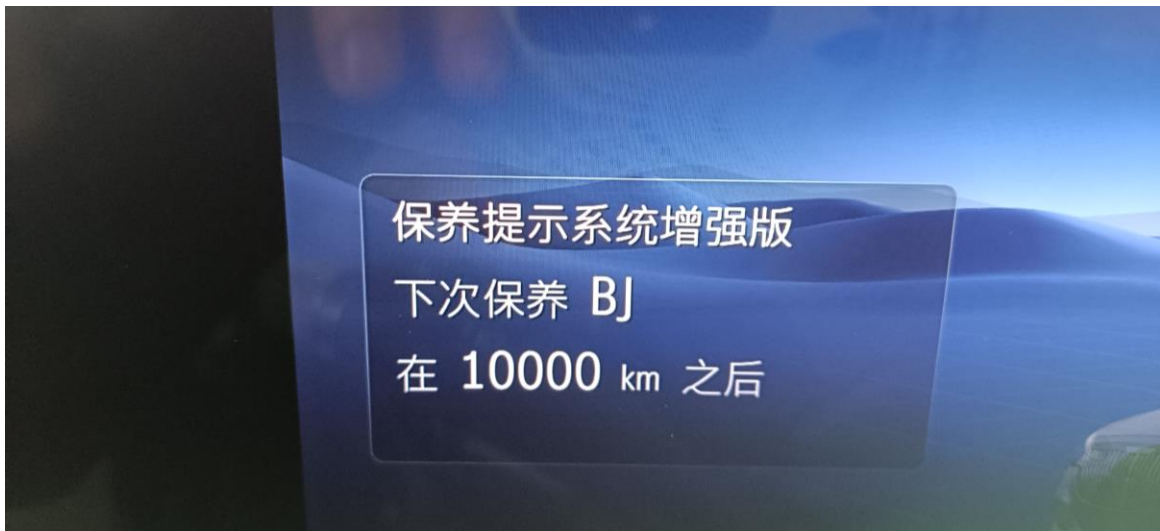
7. The instrument cluster prompts that the next service BJ will be after 10000 kilometers. (See the following figure.)
