Mercedes-Benz S400 Transmission Park Pawl Position Sensor Teach-in

Function Description: The DTC P280600 “Component Y3/8s4 (Park pawl position sensor) was not taught in” is detected in the transmission system of Mercedes-Benz S400. The park pawl position sensor teach-in function must be performed.

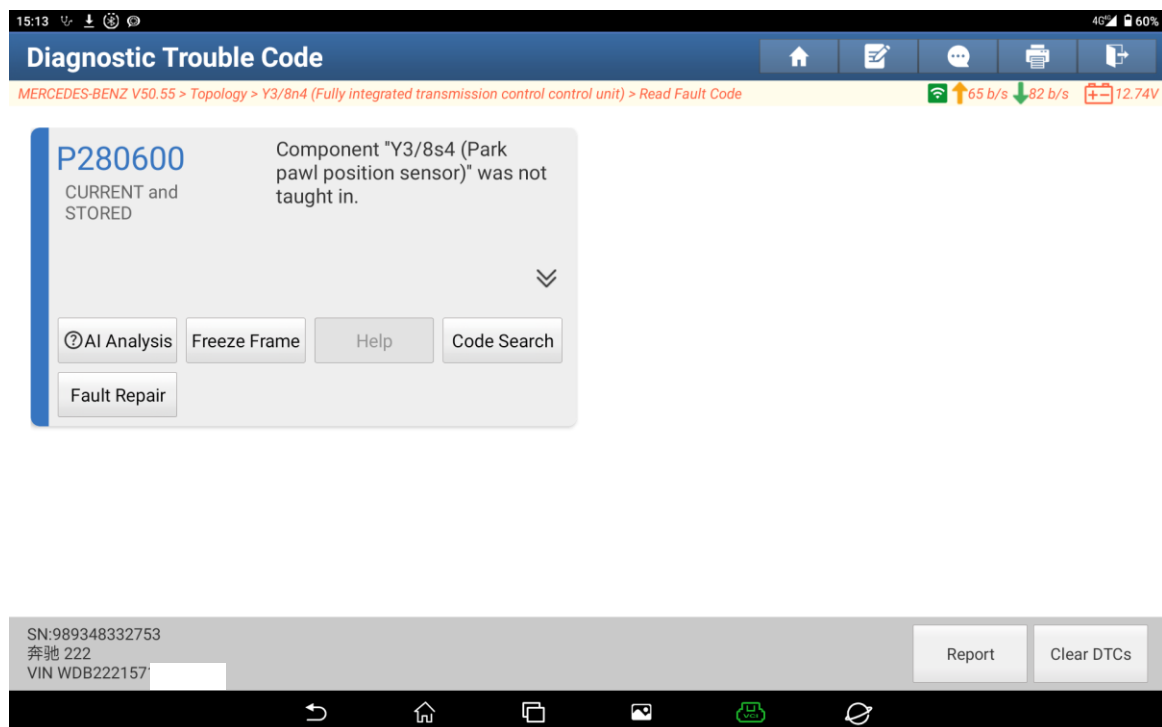
Figure 1

1. The DTC P280600 “Component Y3/8s4 (Park pawl position sensor) was not taught in” is detected in the transmission system. (See the following figure.)

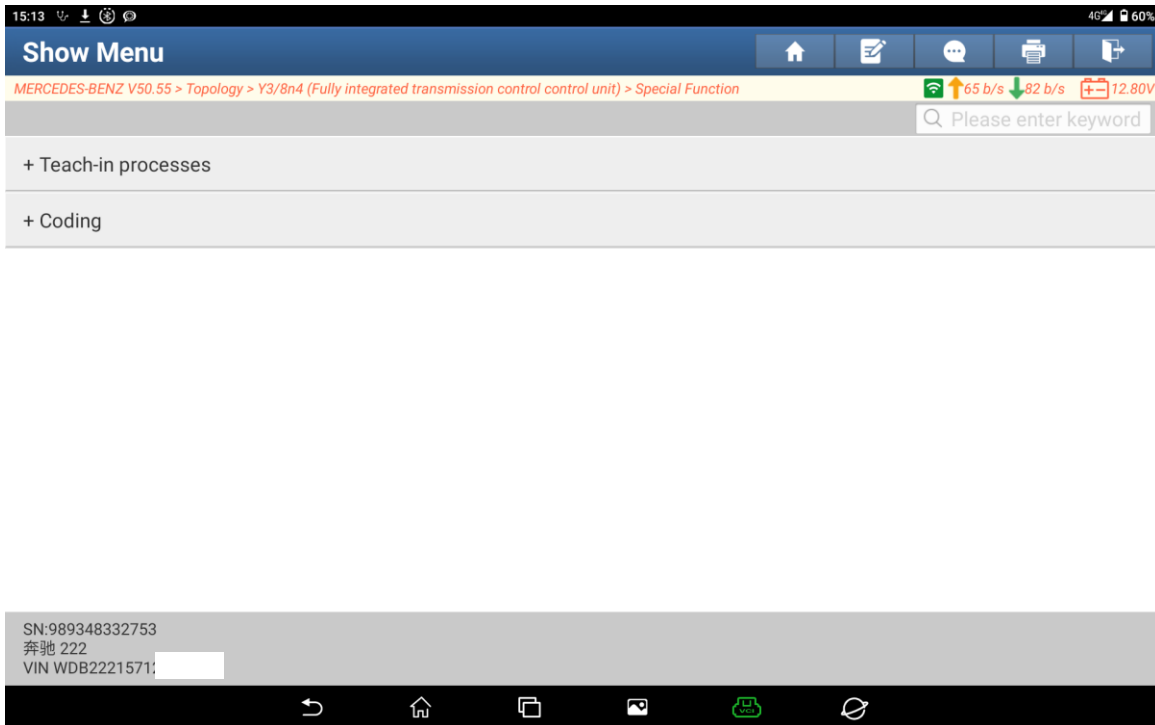
Figure 2

2. Choose [Special Function].

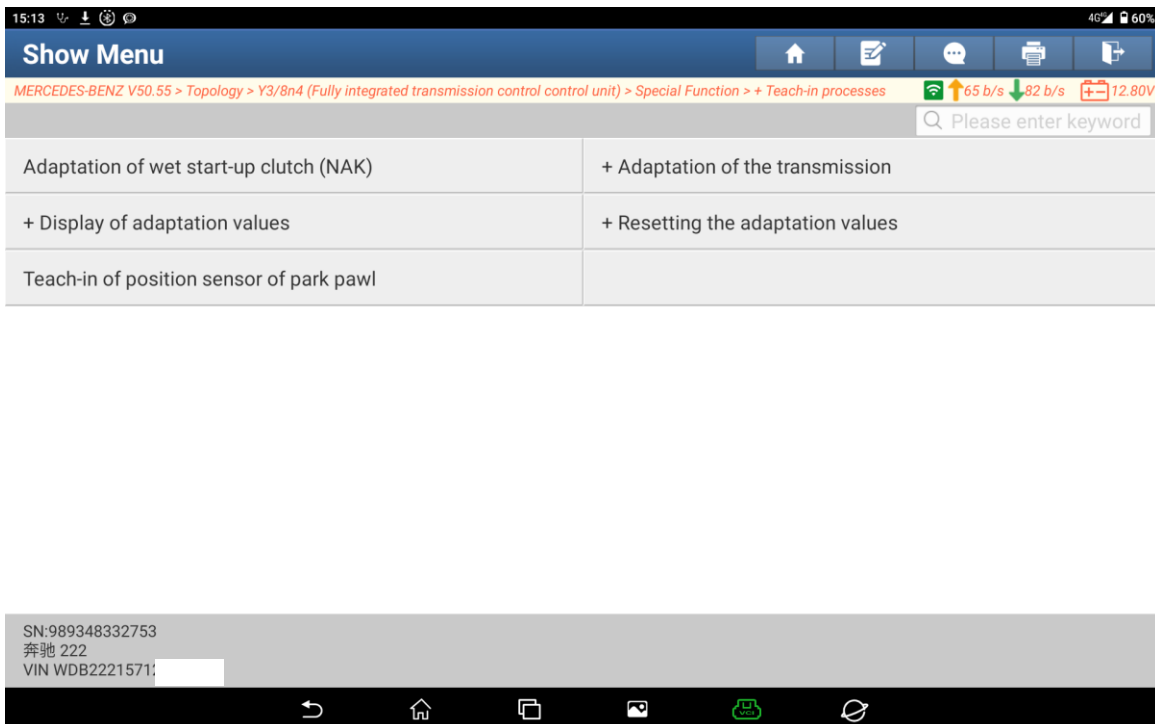
Figure 3

3. Choose [+ Teach-in processes].

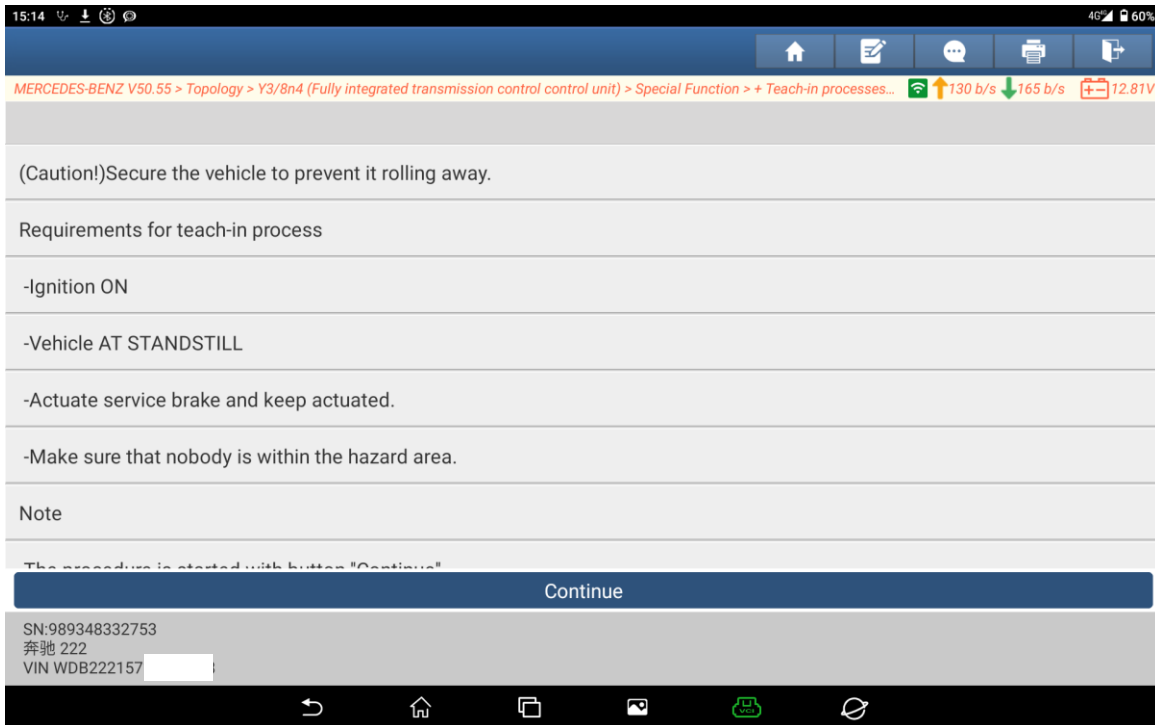
Figure 4

4. Choose [Teach-in of position sensor of park pawl].

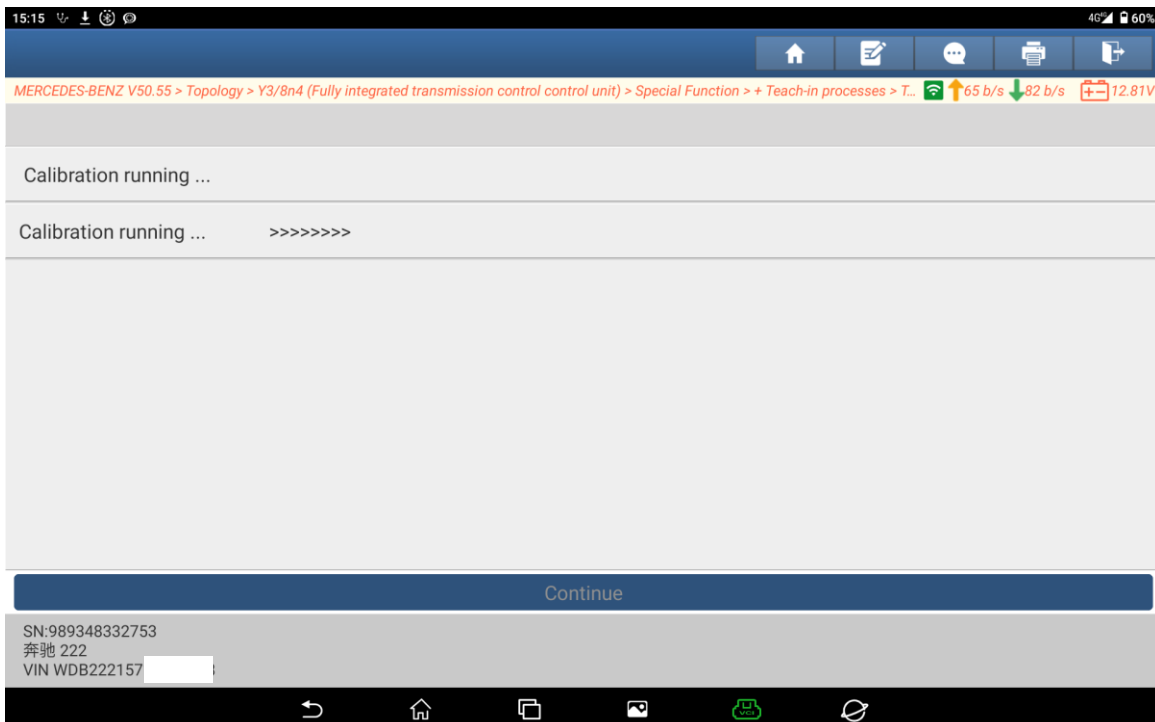
Figure 5

5. Confirm that the conditions are met. Click [Continue].

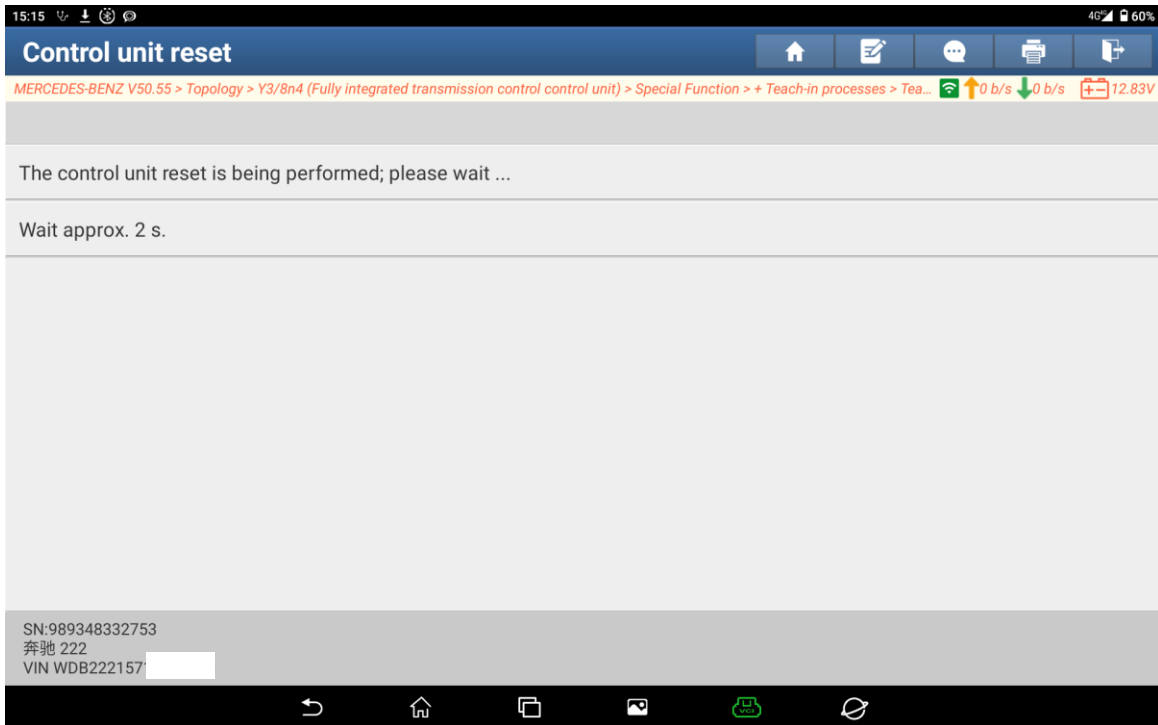
Figure 7

6. Control unit reset in progress. Please wait. (See the following figure.)

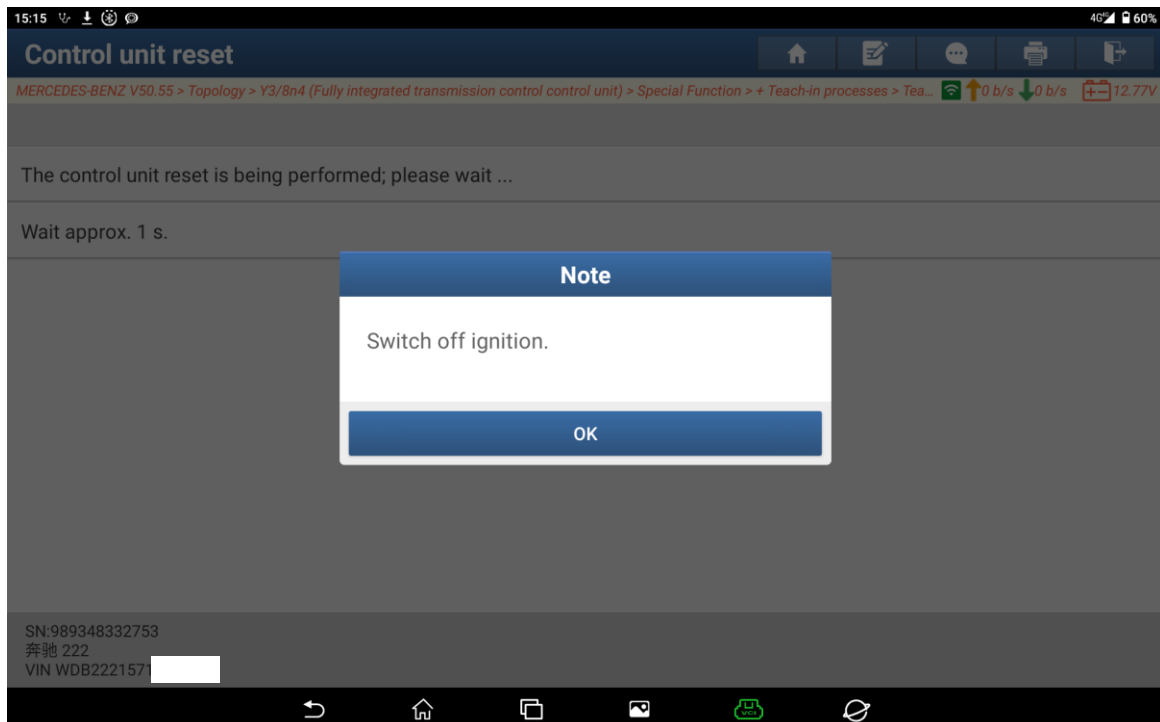
Figure 8

7. Turn off the ignition switch, and then click [OK]. (See the following figure.)

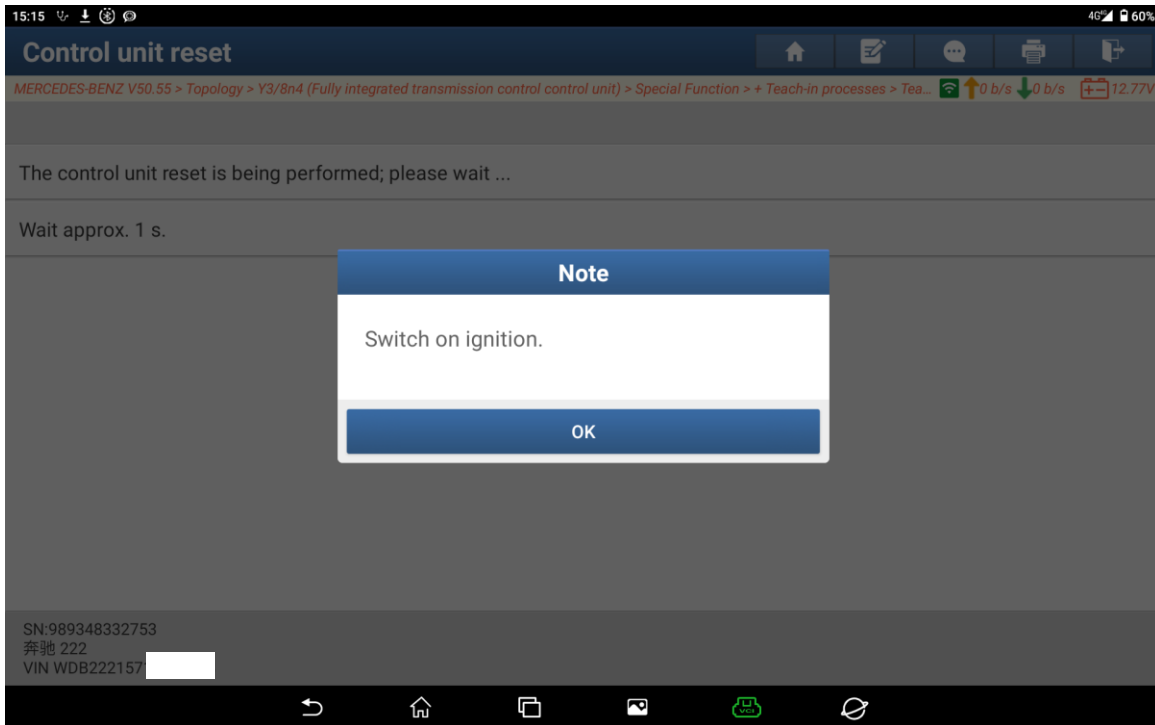
Figure 9

8. Turn on the ignition switch, and then click [OK]. (See the following figure.)

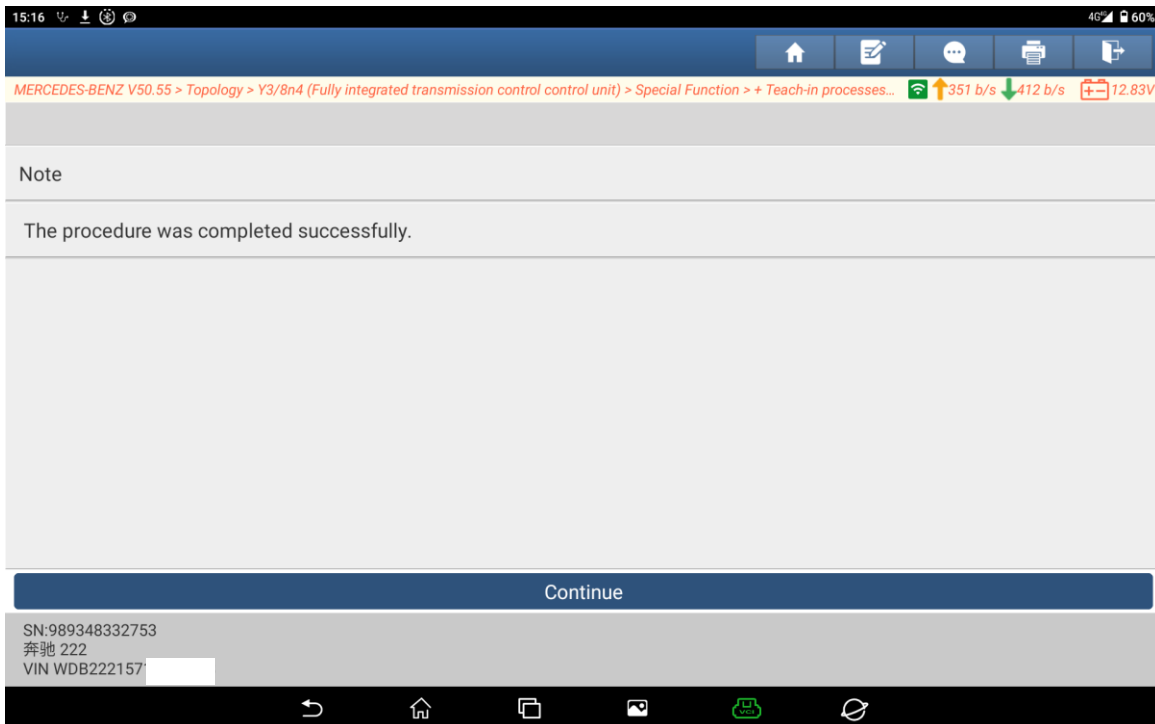
9. Procedure completed successfully. Click [Continue]. (See the following figure.)

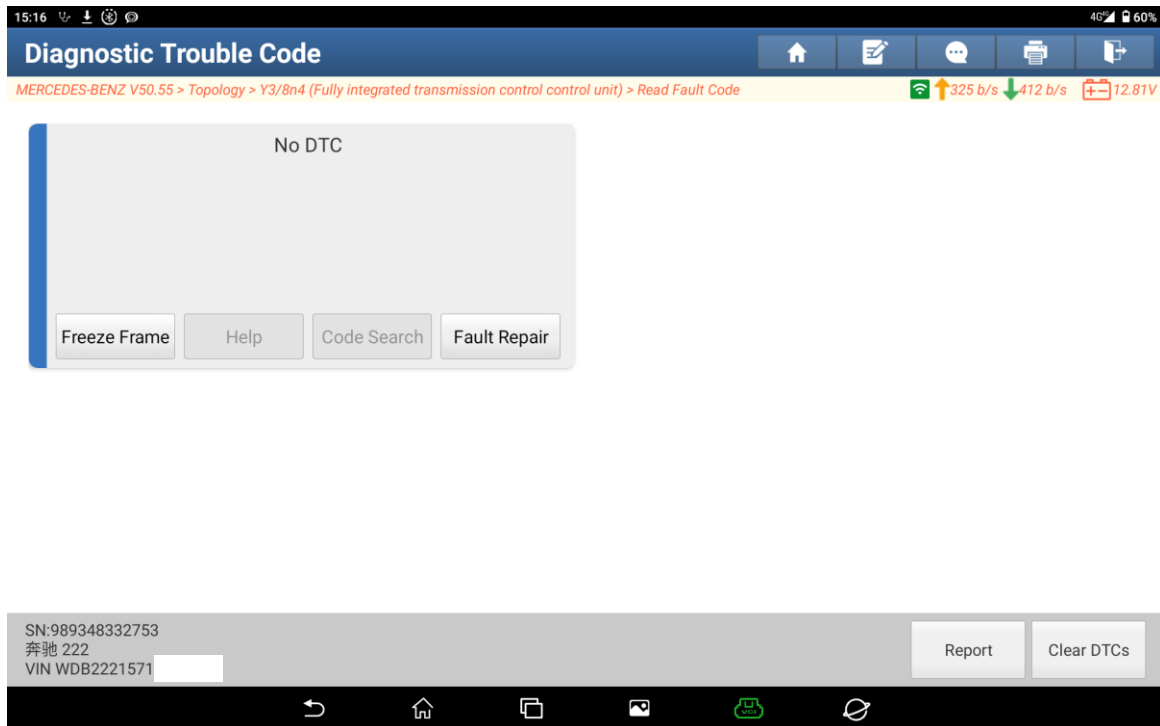
10. The DTC P280600 “Component Y3/8s4 (Park pawl position sensor) was not taught in” is cleared successfully. (See the following figure.)
